# Applied Mechanics and Civil Engineering VI

PROCEEDINGS OF THE 6<sup>TH</sup> INTERNATIONAL CONFERENCE ON APPLIED  
MECHANICS AND CIVIL ENGINEERING (AMCE 2016), HONG KONG, 30–31 DECEMBER  
2016

# Behavior of large deformation and supporting measures in soft rock tunnel

## Integrating *in situ* tests on the excavation damaged zone of underground caverns

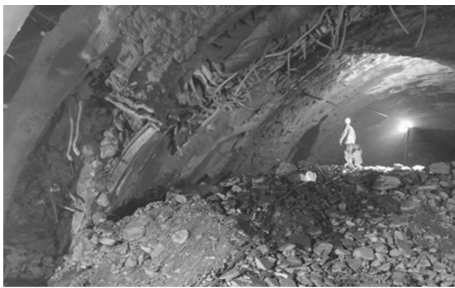
Figure 1. Squeezing of the sidewall.

Fig. 1 shows the typical squeezing phenomenon of the sidewall. Affected by the collapse at the section between K60 + 733 and K60 + 734.2, severe deformation occurred at the section between K60 + 745 and K60 + 753 of the right tunnel. The primary support cracked and peeled off, with steel arch at the left sidewall distorted. More seriously, the primary support intruded into the outline of the secondary lining, the maximum intrusion value even reached 105.3 cm at the section K60 + 745. As a result, the primary support at the intrusion section should be chiseled off and replaced.

During tunneling, typical large-deformation phenomena of soft rock occurred frequently in Huangjiazhai Tunnel, e.g. squeezing of the sidewall, collapse inside the tunnel, severe cracking of secondary lining and shotcrete cracking at the entrance slope.

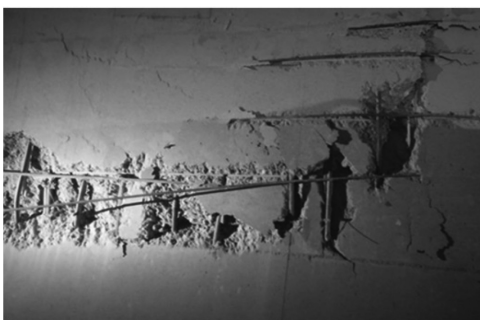
Figure 3. Cracking of secondary lining.

Fig. 3 shows the cracking of secondary lining at the sidewall. The surface concrete gradually peeled off, and the reinforcement meshes were exposed at the section between ZK60 + 690.5 and ZK60 + 707. The above phenomena aggravated when the continuous raining days came.

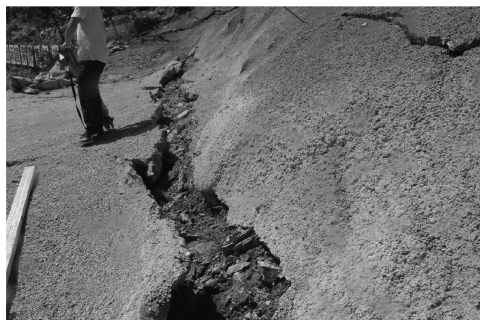
Figure 4. Shotcrete cracking at the entrance slope.

The shotcrete cracking occurred at the entrance slope of right tunnel after continuous heavy rain, as shown in Fig. 4. Through uninterrupted observation, the width and extended length of the crack increasingly expanded as time went on, and the maximum values reached 40 cm and 15 m respectively. Finally, a through crack appeared, and the adjacent parts were at risk from

landslides. According to the monitoring results, the maximum velocity of surface subsidence at the entrance slope exceeded 16 mm/d, which accelerated the expansion of shotcrete crack.
