Dams and Reservoirs under changing Challenges

PROCEEDINGS OF THE INTERNATIONAL SYMPOSIUM ON DAMS AND RESERVOIRS
UNDER CHANGING CHALLENGES – 79 ANNUAL MEETING OF ICOLD, SWISS
COMMITTEE ON DAMS, LUCERNE, SWITZERLAND, 1 JUNE, 2011

Ermenek HEPP—dam and reservoir behavior during impounding

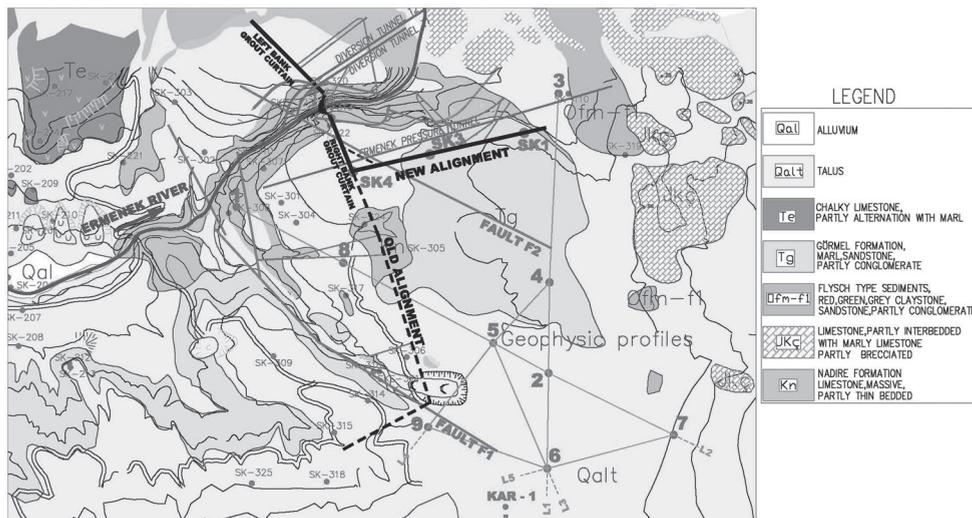
Figure 1. Geological overview at dam area.

A second fault F2 runs parallel to F1-fault, but closer to dam site. An overview of the geological conditions at dam site is given in figure 1.

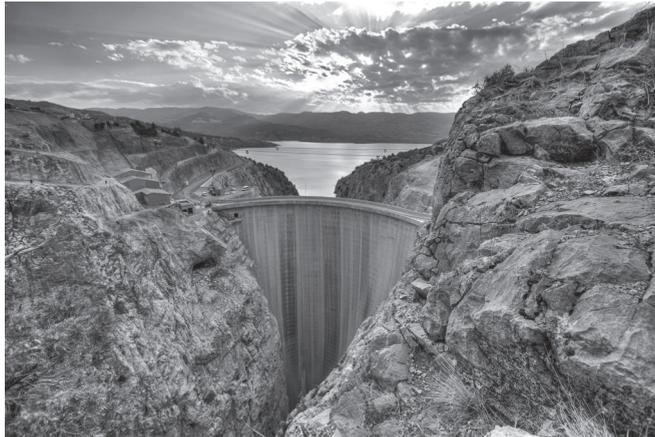
Figure 2. Picture of the dam from downstream taken in October 2010.

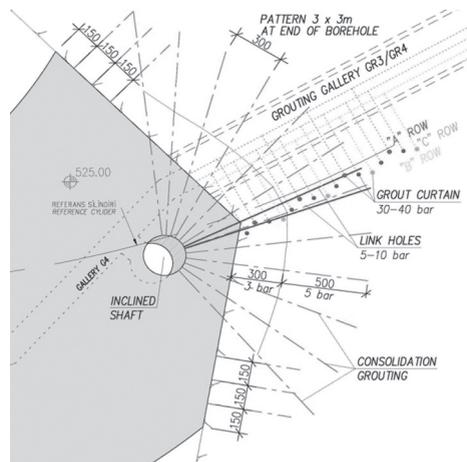
Figure 3. Application of consolidation and link hole grouting from inclined shaft.

The grouting works in the vicinity of the dam were done in two steps: first step was consolidation grouting to improve the contact between concrete and rock and to homogenize the surrounding rock fissured due to blasting during excavation and as second step the grout curtain was drilled and injected. In addition link holes were executed in the abutments, to connect the grout curtain with the dam body concrete. In the vicinity of the dam the curtain was executed as double and partly triple row. Consolidation grouting holes and the link-holes were drilled from the inclined shafts, whereas the grout curtain was drilled from gallery to gallery. Subsequently figure 3 shows the application of the grouting works in the dam abutment.

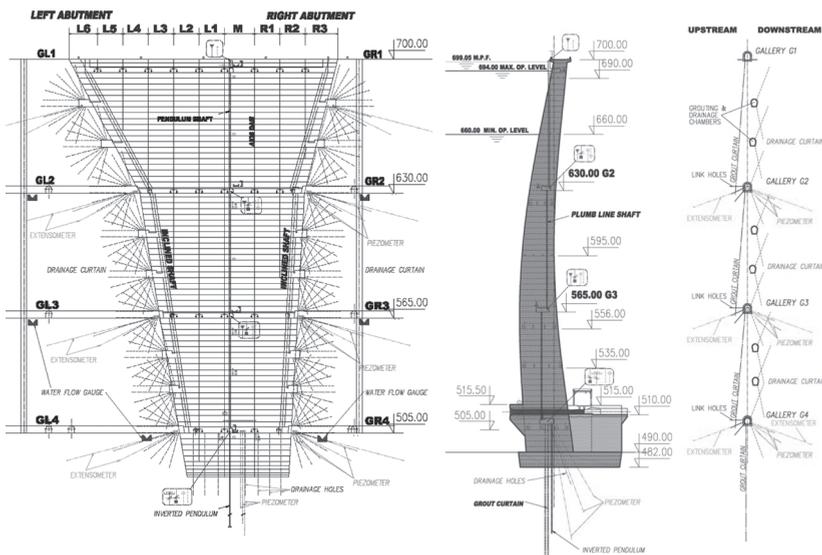
Figure 4. Dam instrumentation and drainage curtain.

the grouting chambers. The ones closer to the curtain are dewatering upwards, the others downwards (see figure 4). In order to observe and control the uplift pressure below the dam foundation drainage holes were drilled from the lower dam body gallery. By means of the drainage curtain in the vicinity of the dam the uplift pressure is controlled which is essential for the dam stability and also for the stability of the abutments. The total water seepage from the galleries and also from the dam abutments is measured by water flow gauging stations which are located at the gallery levels at both sides of the dam.

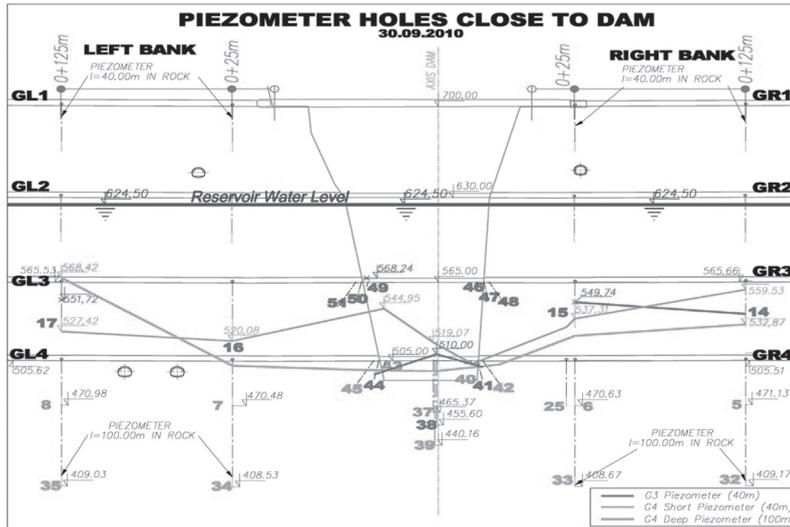
Figure 5. Piezometer measurements in the dam's vicinity.

The figures below show the locations of the piezometer and pore-water-pressures measured in the vicinity of the dam by the end of September 2010.

From uplift point of view it has to be stated that a few piezometers at the left bank showed rather high values which were already at the border of the design assumptions, in particular

the short (5 m) piezometer no. 43 and no. 49 next to the concrete-rock interface. Checkholes drilled into these intersection joints could not confirm the high uplift pressure. So the reason for these wrongly high recorded values might be found in the application of the piezometer installation. The uplift pressure at the dam foundation is below the design assumptions.

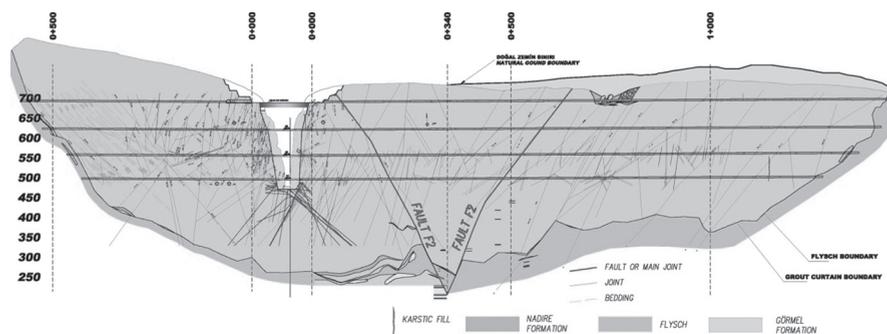
Figure 6. Geological section through the new grout curtain alignment.

The grout curtain is executed as an inclined curtain towards upstream from four galleries with about 70 m vertical distance, connected by link holes at the gallery levels. In general, it is a single row curtain with a final average spacing of 1.20 m. In the vicinity of the dam it is

executed as a double row curtain with reinforcing by a third row where necessary (based on the grout take in the first two rows). The average grout take in the grout curtain holes is 92 kg/m. The grout curtain was finalized in the lower two galleries before the impounding started. The grouting pressure applied was two times the final water pressure after full impounding.

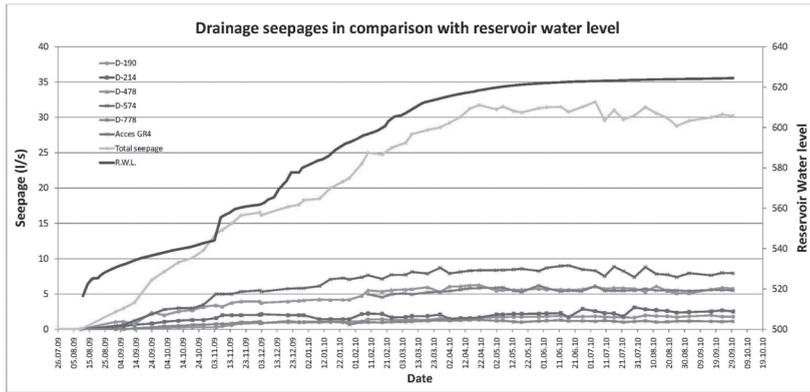
Figure 7. Seepage measurements in the galleries, single bigger seepages and total seepage.

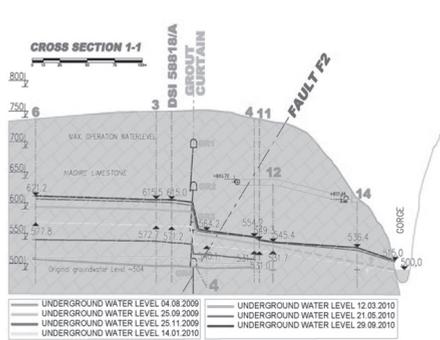
Figure 8. Section through the grout curtain. Figure 9. Development of the piezometer pressure.

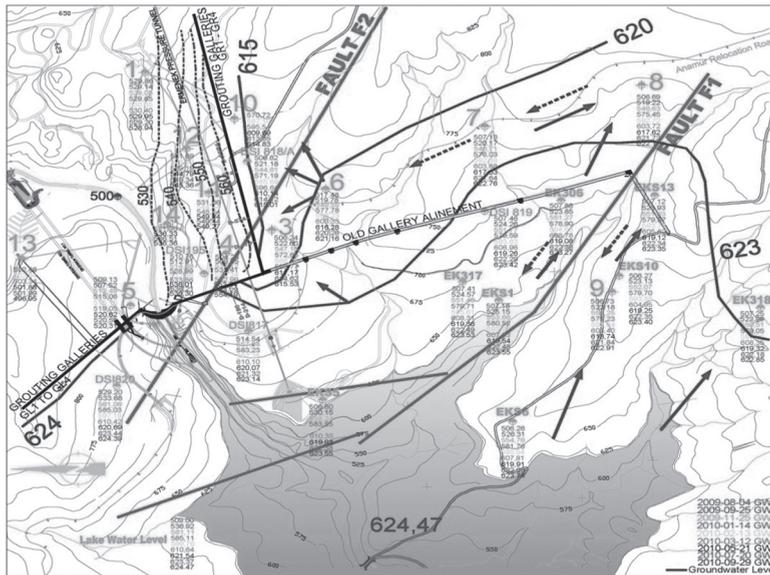
Figure 10. Field piezometer with flow directions.

Several piezometer have been installed on both embankments, up- and downstream of the grout curtain, in order to observe the increase of the groundwater level. The upstream ones show the development of the ground water table during impounding, the downstream ones give an indication of the tightness of the grout curtain. In the figure below the locations of those piezometer and some significant measurement records are shown. The general trend of bank filling can be seen from the contour lines of the groundwater level. This shape of the contour lines remained more or less constant during impounding which indicates also homogenous underground conditions in the reservoir.

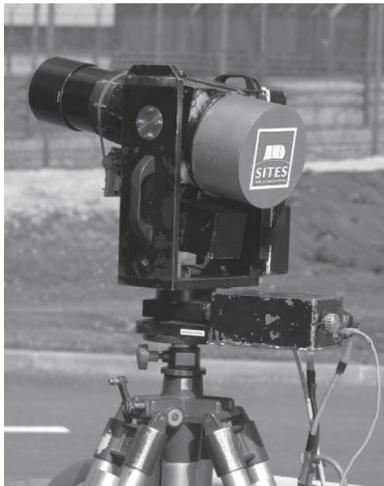
Figure 1. SCANSITES® head.

- An hardware tool with a robotized inspection head and its controllers (Fig. 1).
- A software suite including a database and several dedicated inspection tools.

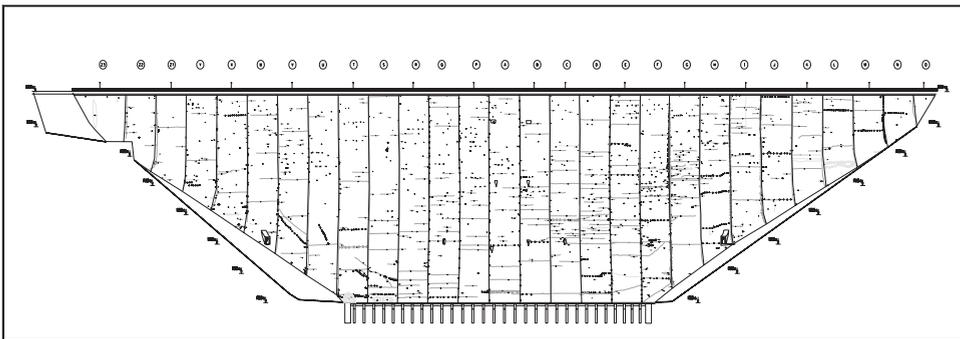
Figure 2. Defects mapping.

The whole system is designed to operate in-field, without heavy carriage. Several dozens of dams have been surveyed by the SCANSITES® and SITES Company team across the world (Figs. 2, 3).

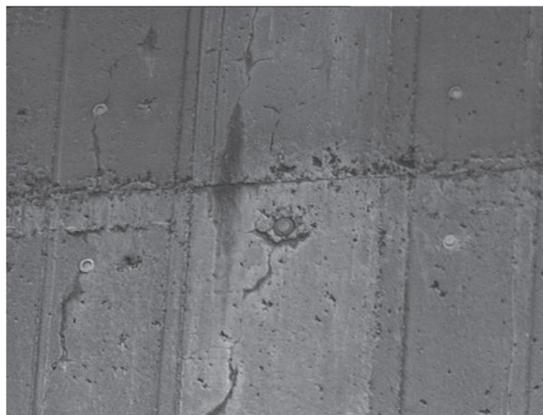
Figure 3. Picture of defect captured with SCANSITES®.

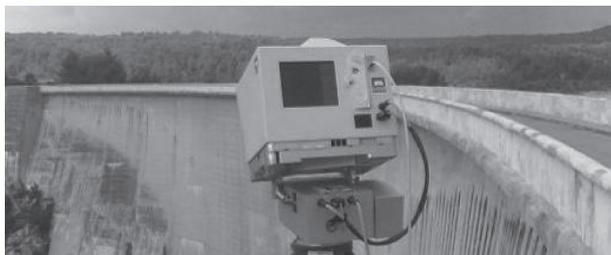
Figure 4. Lidar in operation.

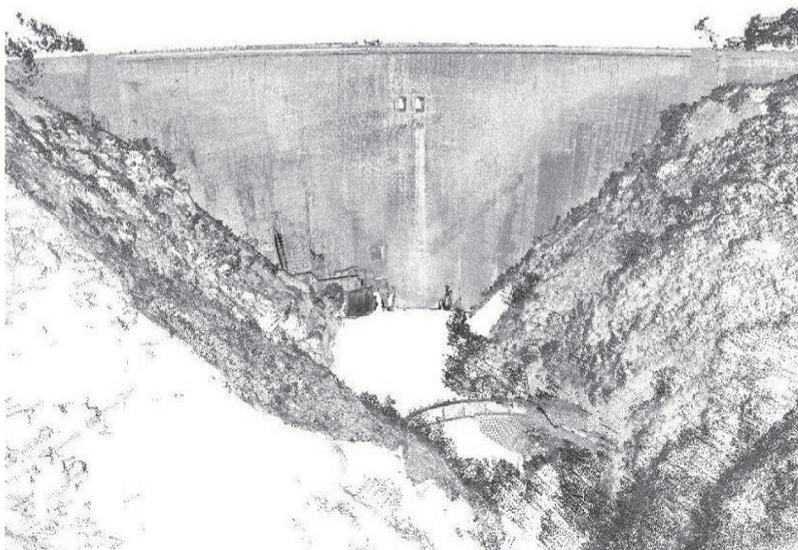
Figure 5. Point cloud of a dam.

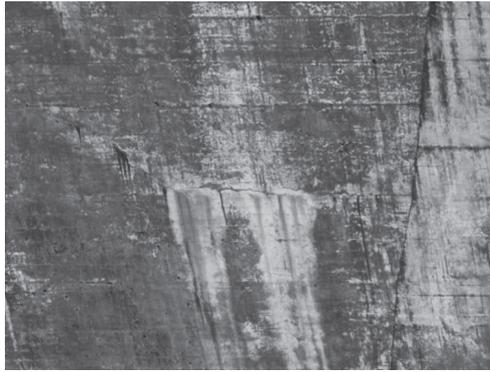
Figure 6. High accuracy picture of degradation captured with the camera.

In this case, the photogrammetric coverage aims to deliver exhaustive and high definition pictures of the structure. The goal is to be able to produce a visual inspection, using 3D referenced pictures. The camera and lenses used can give a pixel equivalent to few millimeters onto the structure, which is enabling to detect the main defects. As photos' orientation is known, each photo can be projected on 3D mesh to texture it (Fig. 6). Next step is to project the textured 3D mesh on a primitive projection (plane, cone, and cylinder) to obtain a map. This projected image is called orthophotography.

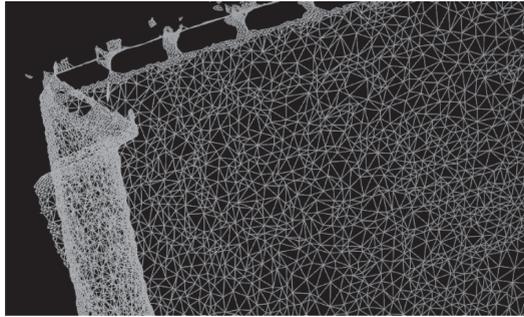
Figure 7. Triangular mapping.

With the Lidar, a complete scan is realized. Based on this point cloud, a triangular mapping (Fig. 7) is generated and converted in a 3D shape. The first use of this 3D shape is to enable the SCANSITES® to locate the defects in 3D.

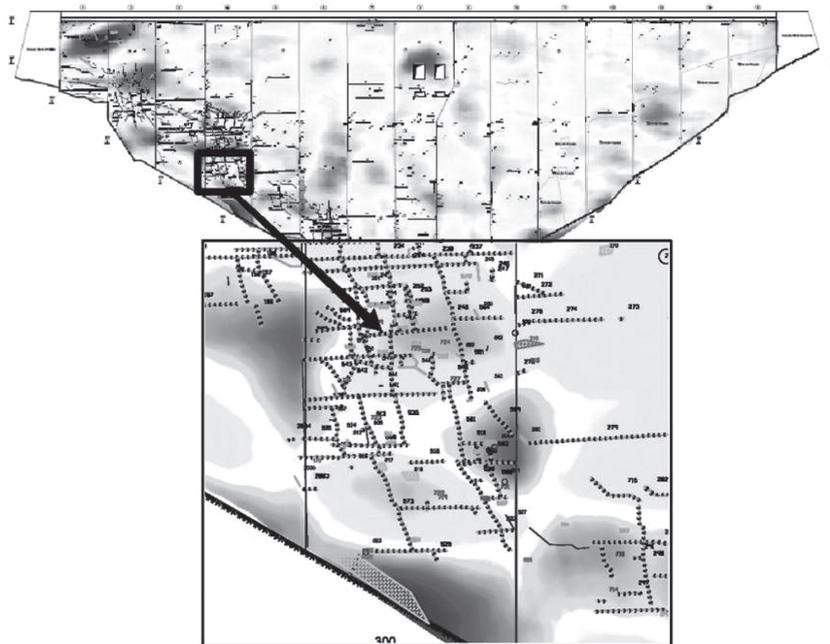
Figure 8. Map overlaying deflection/defects and magnifying.

The first step is to compare the dam's 3D shape to the theoretical shape or to a previous survey. The 3D deflections are extracted, and a map is generated. Two ways of representation are possible. One is a coloured map: each colour depending on deflection value. The other way is to carry out a contour line representation.

The map (Fig. 8) shows a colored layer of the downstream facing deflections vs. defects drawing (mainly cracks).

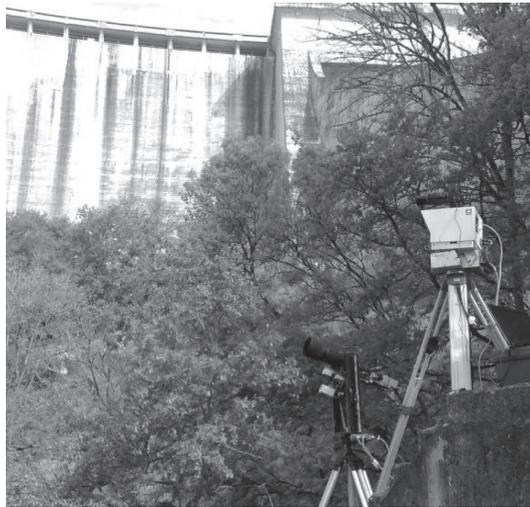
Figure 9. Lidar and SCANSITES® in operation.

The second case study concerns a dam also located in EU but slightly larger: 120 meters high and 250 meters long along the crest. The average distance between SCANSITES 3D® points of view and the downstream facing were about 200 meters (Fig. 9).

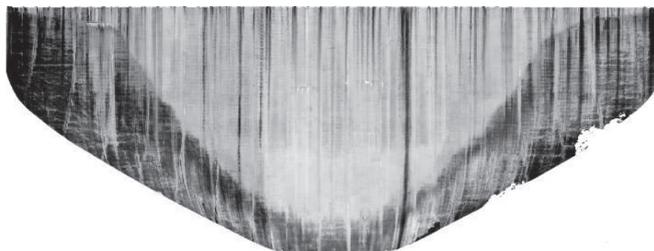
Figure 10. Orthophotography (cylindrical projection).

As carried out on the previous case study (Dam n°1), a Lidar point cloud was generated representing tens million points. In parallel, we covered the whole facing with pictures, projected it on 3D shape, and then on projection cylinder, for a total quantity exceeding 3 billion pixels (Fig. 10).

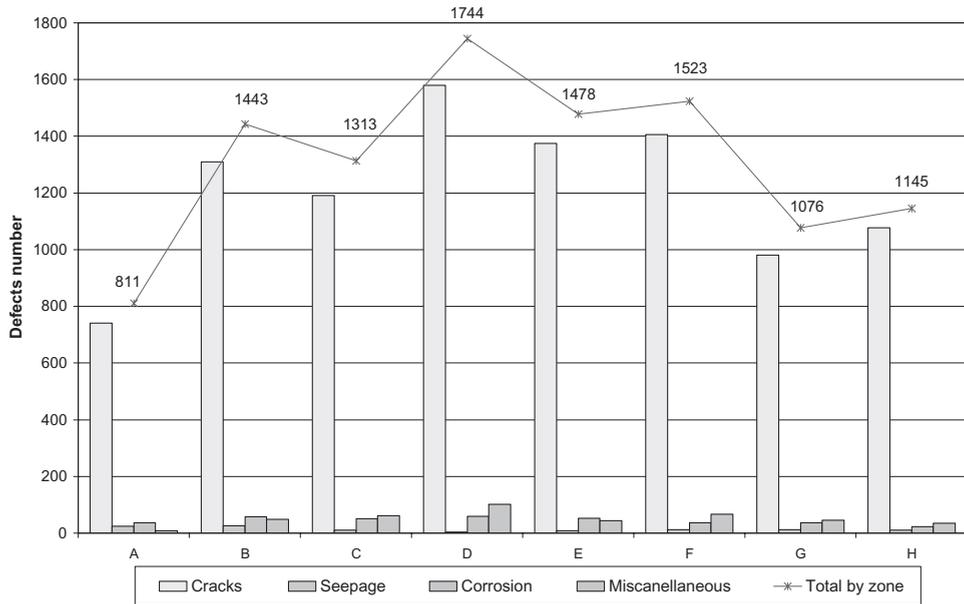
Figure 11. Number of defects by family and zone.

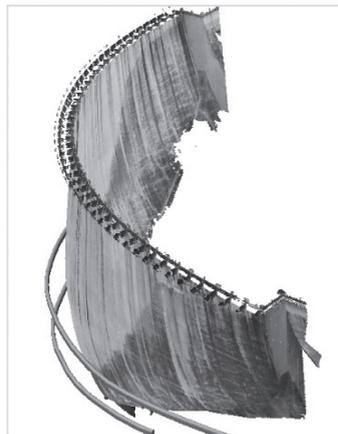
Figure 12. 3D textured shape of a downstream with a surveying of galleries.

As the accurate 3D shape of the dam is known, data for planning sensor installation or wells location can be easily computed (Fig. 12).

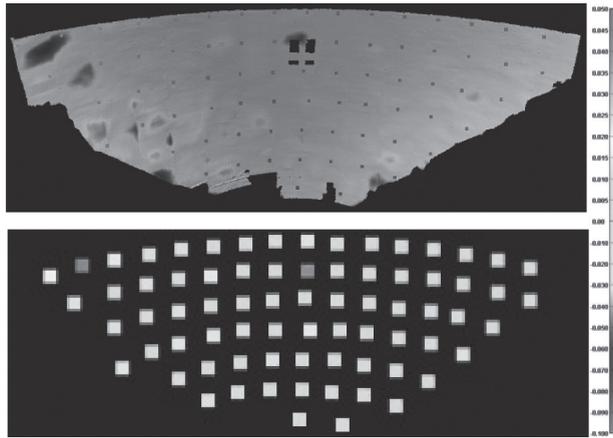
Figure 13. Scanner distortion map superposed to classical surveying targets, and classical surveying targets distortions.

Even if SCANSITES 3D® is less accurate, the high density scan produces some surface definitions near to 3–4 mm uncertainty. Usually working with few millions points, it provides a global information. It widely improves the sensitivity of the geometric diagnosis, showing all details (Fig. 13).

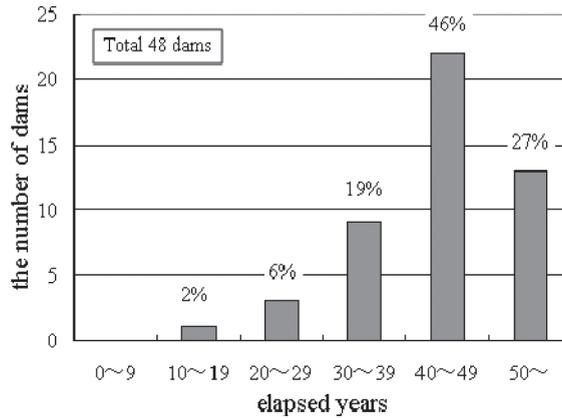
Figure 2. Elapsed years distribution of EPDC dams.

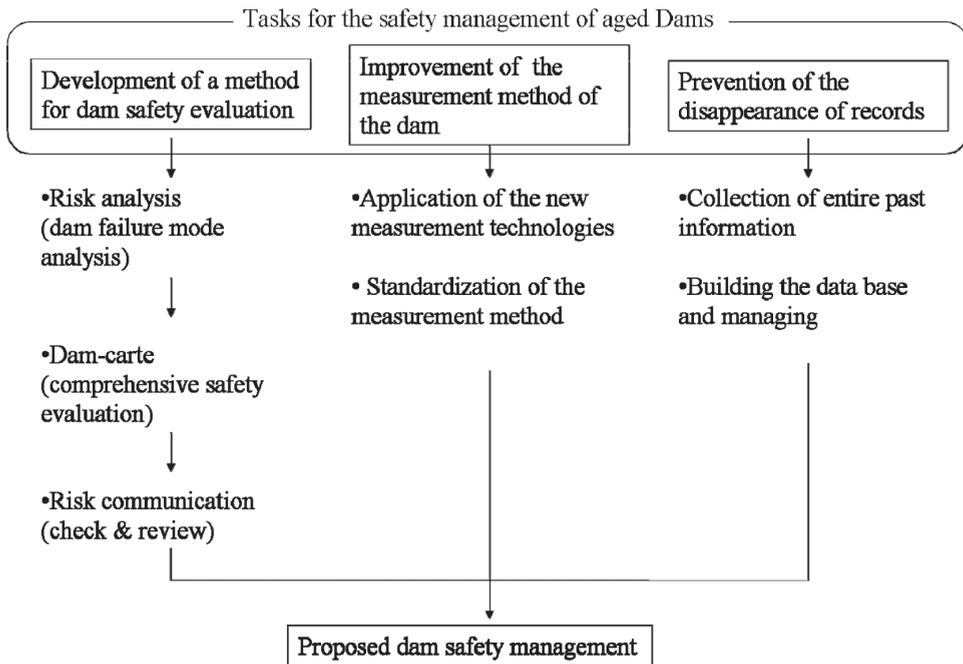
Figure 3. Approach for the safety management of dams.

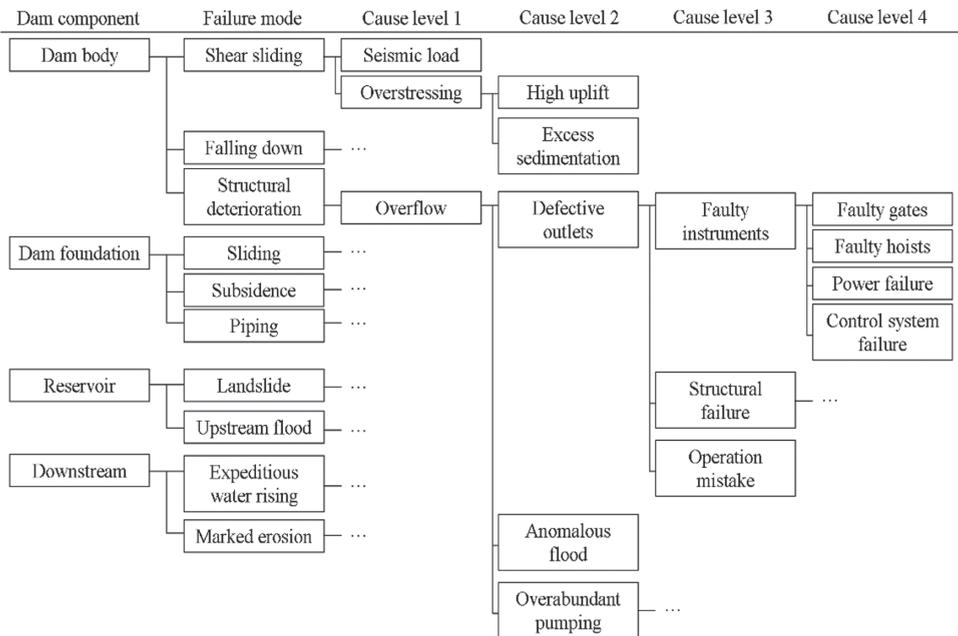
Figure 4. Tree diagram of dam failure mode and cause level.

First of all, we tried to understand the current state of the dam, and to extract the risk connecting with the dam failure, then we referred the technique of the dam failure mode analysis used by Federal Energy Regulatory Commission (FERC)¹⁾, after comparing domestic and foreign standards. Secondly, we made the risk scenario (Fig. 4) taking into account the dam

failure modes and causes by each types of dam. According to the risk scenario, the chief engineer for each dam checks whether there is an event to meet the scenario or not. If there are any items to meet the scenario, they will collect and arrange the evidences, such as the pictures and the monitoring data. They can relate the events occurring in the dam to the dam failure mode, and can improve the knowledge of risk management by doing this analysis.

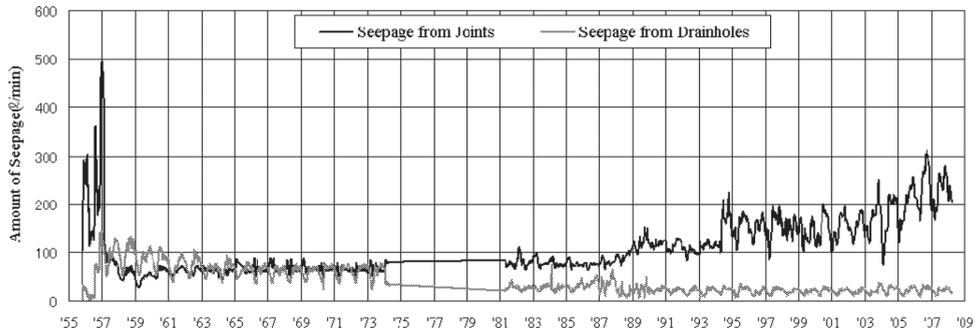
Figure 6. Seepage chart in a concrete-gravity dam.

The total volume of the seepage from the concrete dam is measured together with the seepage from the joints and from the drain holes. The total amount of the seepage from some old dams over 50 years tended to increase gradually. It was too difficult to point out the reason of the increase when the measurement of the seepage from the joint and the drain holes was not separated. If it was separated as shown in Figure 6, it shows clearly that the seepage from the

joints is gradually increasing, and one from the drain holes is decreasing. Figure 8 also shows the linear relation between the seepage from drain holes and the water level recently, so the hydraulic characteristic of the foundation of the dam is thought to be stable.

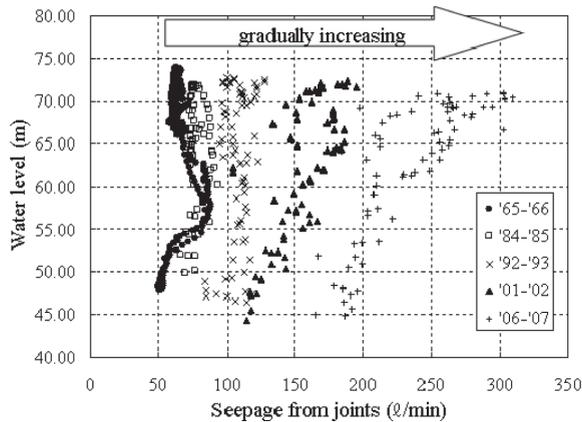
Figure 7. Correlation between seepage from joints and water level.

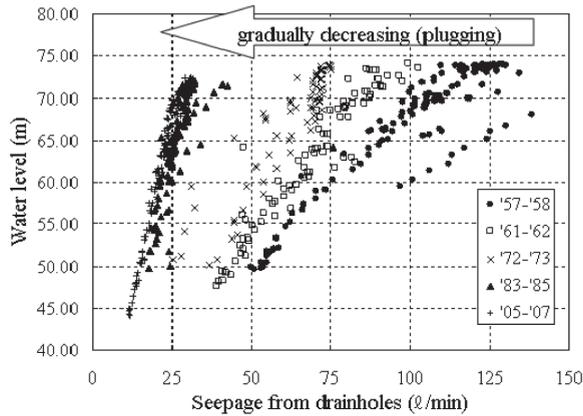
Figure 8. Correlation between seepage from drain holes and water level.

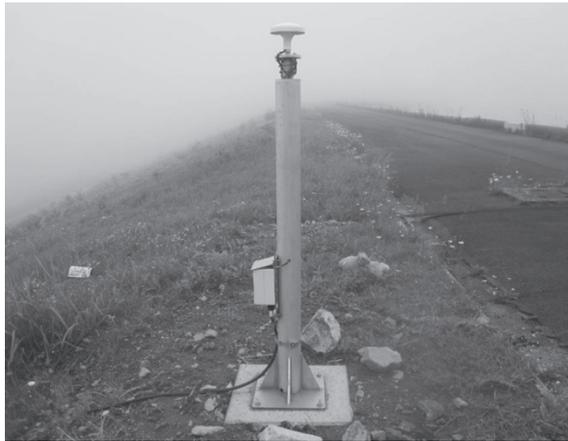
Figure 9. GPS installed on a rock-fill dam of EPDC.

In case of the measurement of the dam displacement, it is necessary to treat the reference point as fixed point to survey a relative position and the movement of the dam. Several decades have passed since the dam construction, and there are some possibilities that the immobility of the reference point is doubted. Since the reference point is believed to be stable, the main reason of the dam displacement is thought to depend on the measurement error. However, the GPS technology is developed and prevailing, and an absolute position can be specified now. We are attempting to confirm the immobility of the reference point by using the GPS technology.

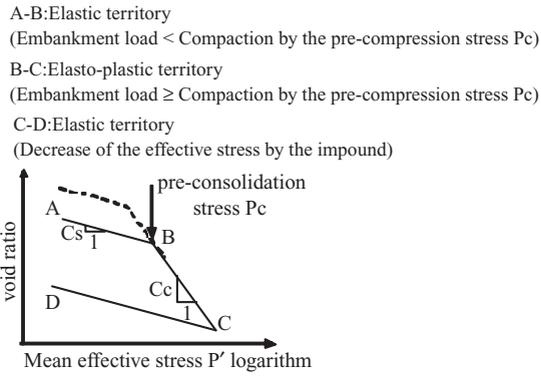
Figure 2. Conceptual diagram for elasto-plastic model.

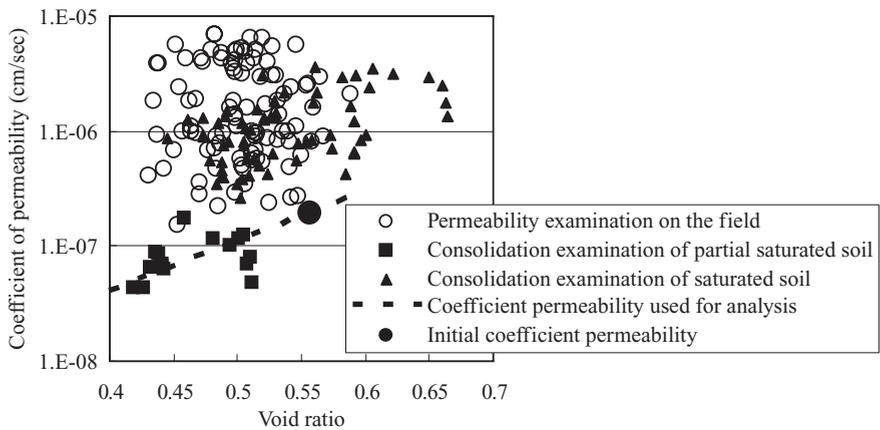
Figure 3. Relation between core material's coefficient permeability and void ratio.

Figure 3 shows the relation between coefficient of permeability and void ratio of core material in Tokuyama dam. The coefficient of permeability of saturated soil obtained from consolidation test is 10 times larger than that of unsaturated soil obtained by consolidation test. The coefficient of permeability obtained from permeability test on embankment surface at site matches closely with that of saturated soil obtained by consolidation test. The coefficient of permeability used for the analysis is set based on the result of consolidation test of unsaturated soil, since the core material is unsaturated during embankment. The initial coefficient of permeability is obtained by consolidation test in which void ratio of the material was adjusted to the average void ratio in embankment area at site. Because the material of core with small void ratio tends to have lower permeability, coefficient of permeability is changed according to the change of void ratio obtained from the analysis, using the relationship between the coefficient of permeability and void ratio obtained from the consolidation test shown in dotted line in Figure 3. In the analysis, the coefficient of permeability is changed in every embankment stage.

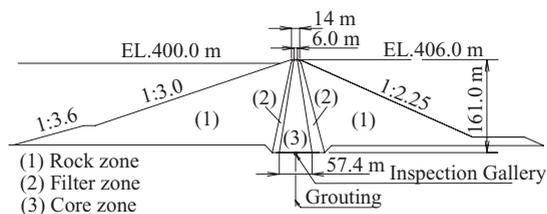
Figure 4. Cross-section.

Figure 4 shows the cross section of Tokuyama dam used for the analysis. Tokuyama Dam has the height of 161 m, upstream slope gradient of 1:3.0, downstream slope gradient of

1:2.25, and its symmetric core slope has a gradient of 1:0.16. The analysis is implemented for the dam body and the foundation. The analysis horizontal range is about the double of the base width and the vertical range is about the double of the dam height. The number of elements is 5524 in the finite elements method. As the boundary conditions, the horizontal displacement at the side of the foundation is 0 and that at the underside is fixed. As the hydraulic boundary conditions, the distribution load and hydrostatic pressure based on the reservoir level is set on the upper face of the dam. Also the vertical load based on the difference between the wet density and saturated density is set at the dam body under water. The pore water pressure at the lower rock zone is set as 0 during the embankment and impounding period. As the boundary conditions, the water pressure based on the reservoir level at the upper side of the foundation, the hydrostatic pressure at the lower side of the foundation and the undrained condition at the underside are set respectively.

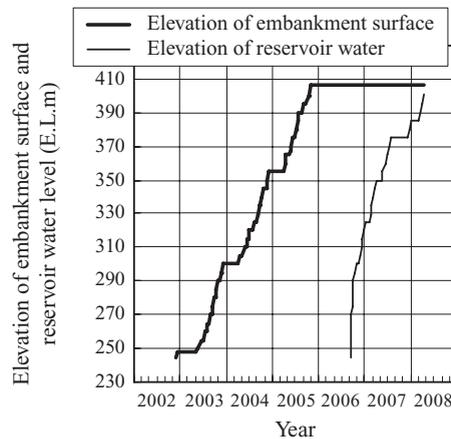
Figure 5. The process of embankment and impounding turned into a model by FEM analysis.

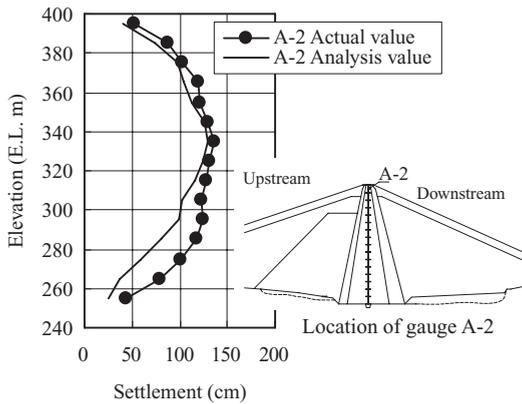
Figure 6. Actual value and analysis value by differential settlement gauge (Maximum water level).

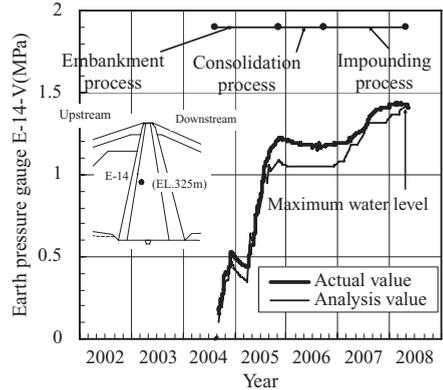
Figure 7. Chronological change of Vertical Earth Pressure.

Figure 7 and Figure 8 show another comparison at the same location between numerical results and data measured by vertical earth pressure gauge, E-14 set up in the upper side of middle elevation of core zone and E-15 set up in the center part. The comparison of the value at E-14 between numerical results and data measured at site shows a close similarity, whereas that of E-15 does not. At E-15, earth pressure is numerically predicted larger by 30% than observed data.

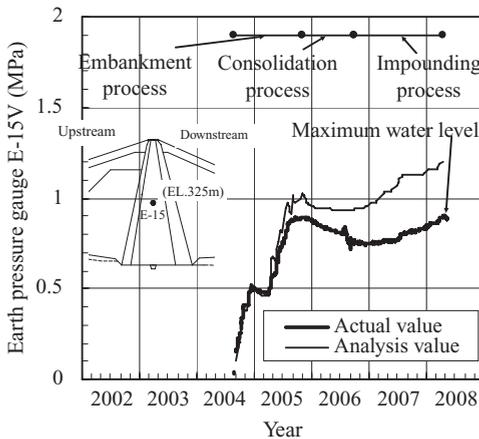
Figure 8. Chronological change of Vertical Earth Pressure.

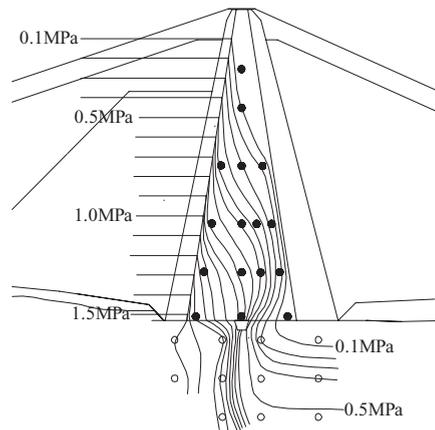
Figure 9. Distribution map of Pore water pressure on highest high-water level (actual value).

Figure 9 and Figure 10 show a comparison of pore water pressure between numerical results and measured data at the time of maximum water level during the first impounding.

Residual pore water pressure exists after the completion of embankment, but the osmotic pressure in the core rises due to the impounding. Both observed data and numerical prediction show the dissipation of pore water pressure when the water level reaches the maximum water level, leaving the profile of pore water pressure high at the upper stream and low at the downstream.

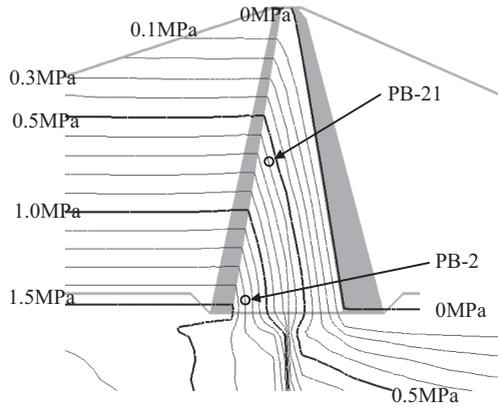
Figure 10. Distribution map of Pore water pressure on highest high-water level (analysis value).

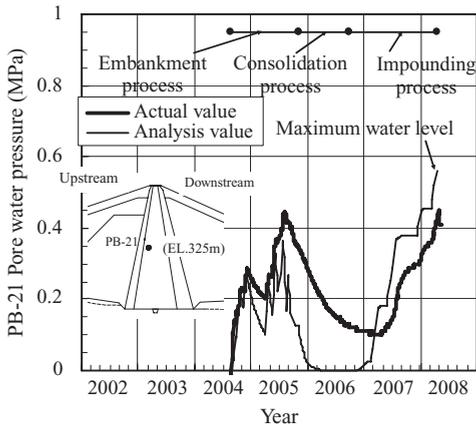
Figure 11. Chronological change of pore water pressure.

Figure 11 and Figure 12 show a comparison of pore pressure at the same location between numerical prediction and observed data measured by pore pressure gauge at PB-21 set up in the upper side of middle elevation of core zone and PB-2 set up in the lower elevation. It shows similarity between numerical result and observed data of pore water pressure during the process of embankment and at the time of the maximum water level. Differences between numerical prediction and observed data are seen from November, 2005 to March, 2007. During this term, observed data tends to be larger than numerical prediction. The dissipation of water pressure is calculated by seepage analysis, on the assumption that the core is saturation. On the other hand, the core is unsaturated during this term, so the coefficient of permeability is small, seemingly resulted in the delay of dissipation of pore water pressure.

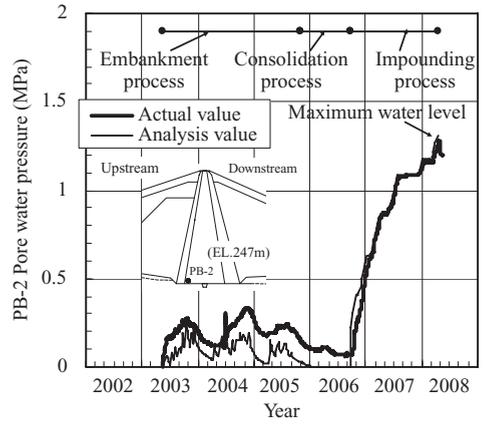
Figure 12. Chronological change of pore water pressure.

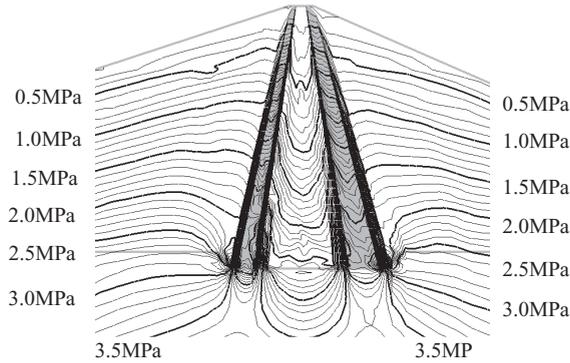
Figure 13. Distribution map of major effective principal stress when the embankment was completed (analysis value).

Figure 13 shows distribution contour of major effective principal stress at the end of embankment obtained by the embankment analysis. The generation of arching phenomena due to the difference of rigidity between core zone and filter zone leads the stress reduction in the core zone.

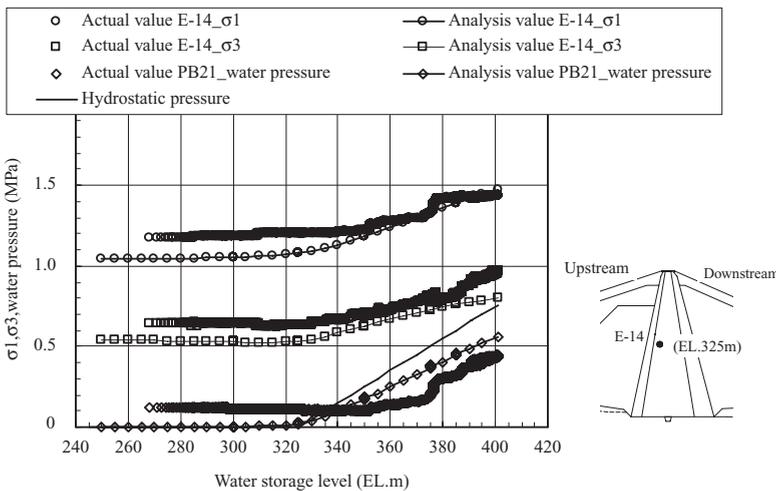
Figure 14. Chronological change of major, minor principal stress and Pore water pressure on E-14.

Figure 14 shows a comparison of the major principal stress σ_1 , minor principal stress σ_3 and pore water pressure at the same location between numerical prediction and data measured at E-14. Observed major principal stress σ_1 and minor principal stress σ_3 are calculated based on the data from trihedral earth pressure gauge. The numerical prediction is successful to simulate the qualitative trend of pore water pressure inside of the core, major principal stress in total stress σ_1 and the minor principal stress in total stress σ_3 , to increase parallel with the water level in the reservoir. Observed data and numerical prediction of minor principal stress σ_3 shows a close similarity. In addition to that, major principal stress in total stress σ_1 and minor principal stress in total stress σ_3 surpass pore water pressure in every point.

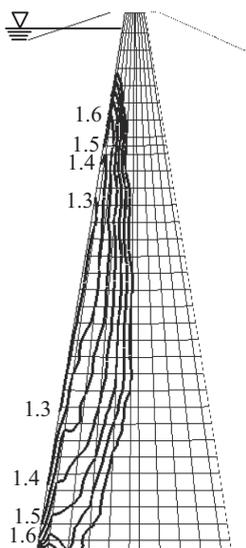
Figure 15. Distribution contour of safety factor against hydraulic fracturing in the core when the water level reached maximum water level (analysis value).

Figure 15 shows the distribution contour of safety factor against hydraulic fracturing at the core zone obtained by the analysis at the time of the maximum water level. The safety factor against hydraulic fracturing becomes the smallest at the border of the core zone and the filter zone at the height of 1/3–2/3 of the dam height. The smallest safety factor is approximately 1.3.

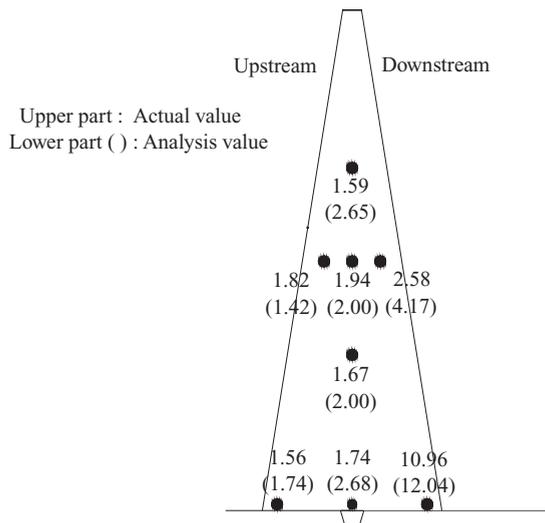
Figure 16. Safety rate against hydraulic fracturing of central core.

On the other hand, Figure 16 shows both the safety factor against hydraulic fracturing in the core zone obtained from the observed data and that from the analysis. The smallest safety factor obtained by the observed data is 1.56, and that of numerical prediction is 1.42. Although observed data is a little larger than numerical prediction, safety factors in the core zone are nearly equal.

From these points, smallest safety factor against hydraulic fracturing at the core zone in Tokuyama dam is 1.56 based on observed value and 1.4 from numerical prediction, which confirms “safety factor ≥ 1.0 ” in every point.

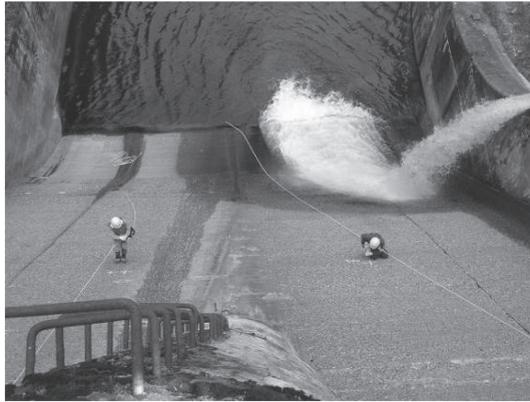
Figure 1. Dam surface inspection by rope access.

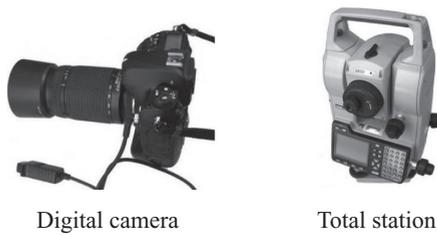
Digital camera

Total station

Figure 2. Image measurement equipment.

image displayed on a monitor and the widths of the cracks at the position that can be recognized on the cracks with the naked eye are evaluated (Figure 4). Main instruments of the system are a single-lens reflex digital camera, a non-prism total station (instrumental tolerance equals plus or minus 3 mm and plus or minus $[2 \times 10^{-5} \times \text{distance}]$), an image processing unit and a data logging unit (Table 1).

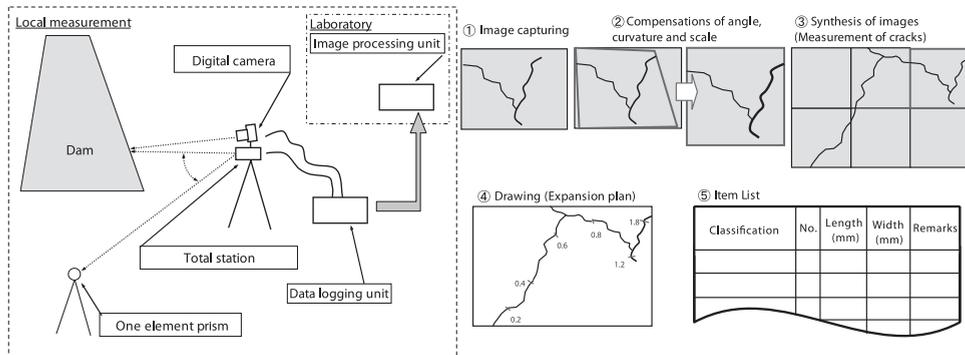
Figure 4. Flow of image measurement technique.

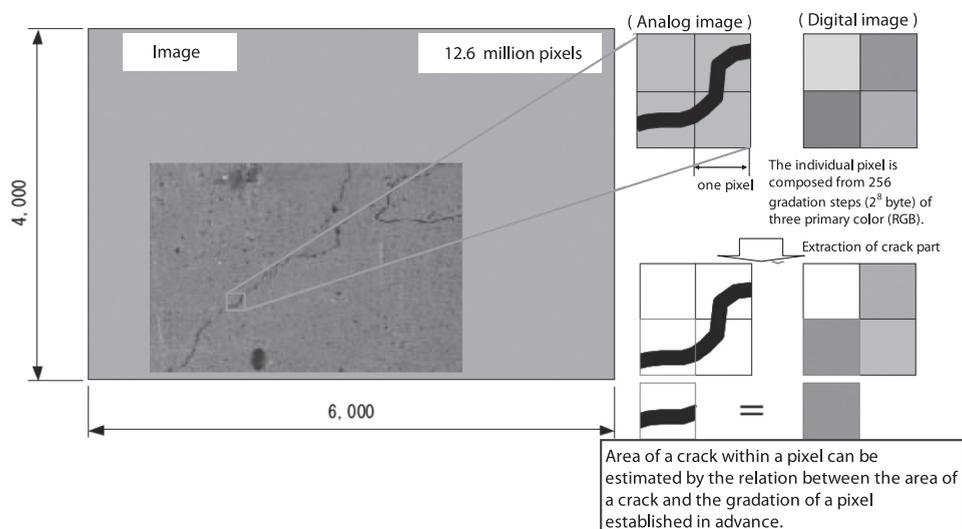
Figure 5. Evaluation method of crack width.

a crack which is narrower than the resolution can be measured if the relation between the ratio of the crack over to one pixel and the gradation level of the pixel is established (Hiroshi 2004).

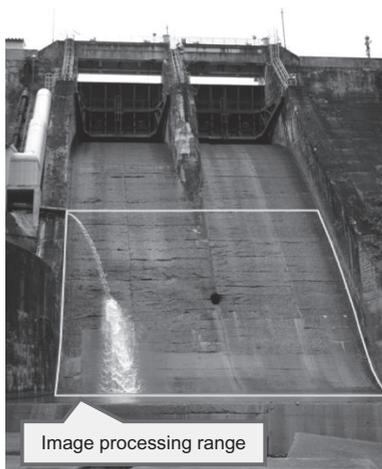
Figure 6. Distant view on the dam downstream side.

distant view on the dam downstream side. Compensations of angle, curvature and scale were carried out to all the images, and these images were synthesized into several front view images. Cracks of 0.2 mm width or wider could be found individually while stains, concrete joints and formwork marks were checked on a monitor. Figure 7 shows an example of a sketch of cracks on a synthesized image after the compensation of angle, curvature and scale.

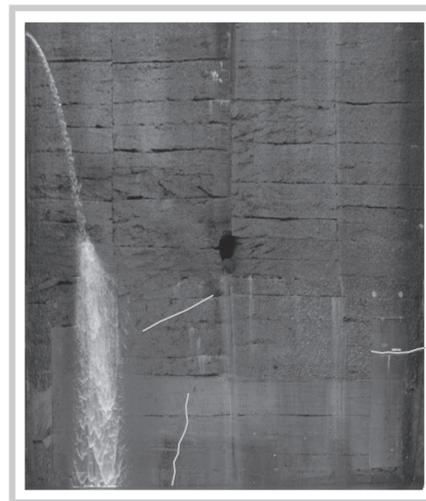
(Image processing area: about 378m² (The number of images:28))

Figure 7. Dam downstream side image after image processing.

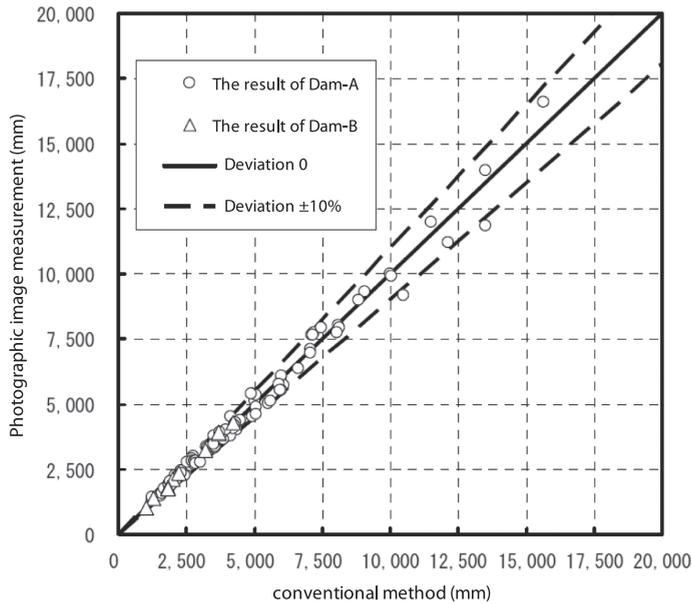
Figure 8. Comparison results of crack length.

Moss and stain did not prevented any cracks from being found in the verification. Some painted concrete areas with reflection of sunlight prevent some cracks from being found. In such cases, images were captured again at other time considering the reflection of sunlight. Comparing all found crack lengths of the two dams with opening of 0.2 mm width or wider with those found by the conventional method, each deviation was within plus or minus 10% in about 97% of all cracks and the deviation of accumulated length of individual components of the dams varies from minus 2.1% to plus 6.2% (Table 2, Figure 8). The deviation of width of the cracks was within plus or minus 0.1 mm in about 98% of all cracks.

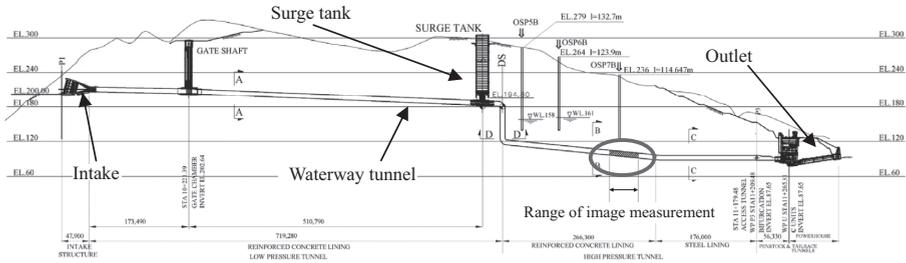
Figure 9. Longitudinal section profile of the waterway tunnel.

Next, authors show an application example for a waterway tunnel inspection. The KANSAI Electric Power Group is engaged in an O&M consulting business of an overseas hydropower IPP, the San Roque Multi-purpose Project in Philippines, and in the waterway tunnel inspection of the San Roque power plant, the photographic image measurement has been conducted in 2009. Table 3 and Figure 9 show the outlines of the San Roque Dam and a longitudinal section profile of the waterway tunnel. Because the inside diameter of the waterway tunnel, which is pressure tunnel with concrete lining, is 8.5 m, it is necessary to set up a tall temporary scaffold for visual monitoring of cracks in order to observe the crown of the tunnel in detail. Since dewatering period of the waterway tunnel is a very short time, and a hatch of the waterway tunnel is less than 1 m in diameter from which inspection equipment are brought in. It is difficult to carry out enough research in a short time, so KEPCO introduced the photographic image measurement. The image measurements were carried out at sections where the bedrocks were weak and many cracks were found. Two locations were selected for the photographic image measurement, which were 29 m wide and 3 m high, 21 m wide and 3 m high respectively, with a total area of 150 m². Because the surface of the tunnel was stained with the mud, images were taken after cleaning the surface by high-pressure water washing. The measurement was completed in about three days. After bringing back the images to Japan, authors conducted image processing in our laboratory. Because the waterway tunnel has a simple circular cross section and the concrete surfaces had formwork marks, the image syntheses were relatively easy.

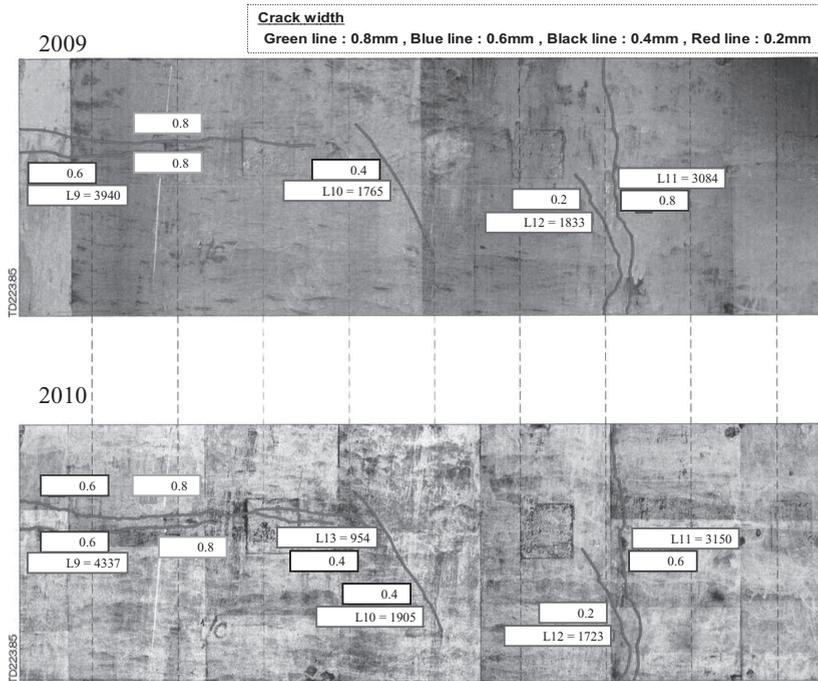
Figure 10. Result of waterway tunnel image analyses.

Table 4 and Figure 10 show comparison results of some of the data obtained from the image measurement in 2009 and 2010. As for the results of 2010, authors couldn't distin-

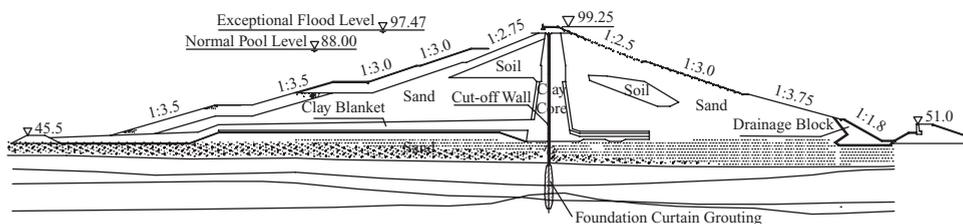
Figure 1. Sketch map of cut-off wall in Hualiangting Reservoir.
