Dams and Reservoirs under changing Challenges

PROCEEDINGS OF THE INTERNATIONAL SYMPOSIUM ON DAMS AND RESERVOIRS
UNDER CHANGING CHALLENGES – 79 ANNUAL MEETING OF ICOLD, SWISS
COMMITTEE ON DAMS, LUCERNE, SWITZERLAND, 1 JUNE, 2011

Ermenek HEPP—dam and reservoir behavior during impounding

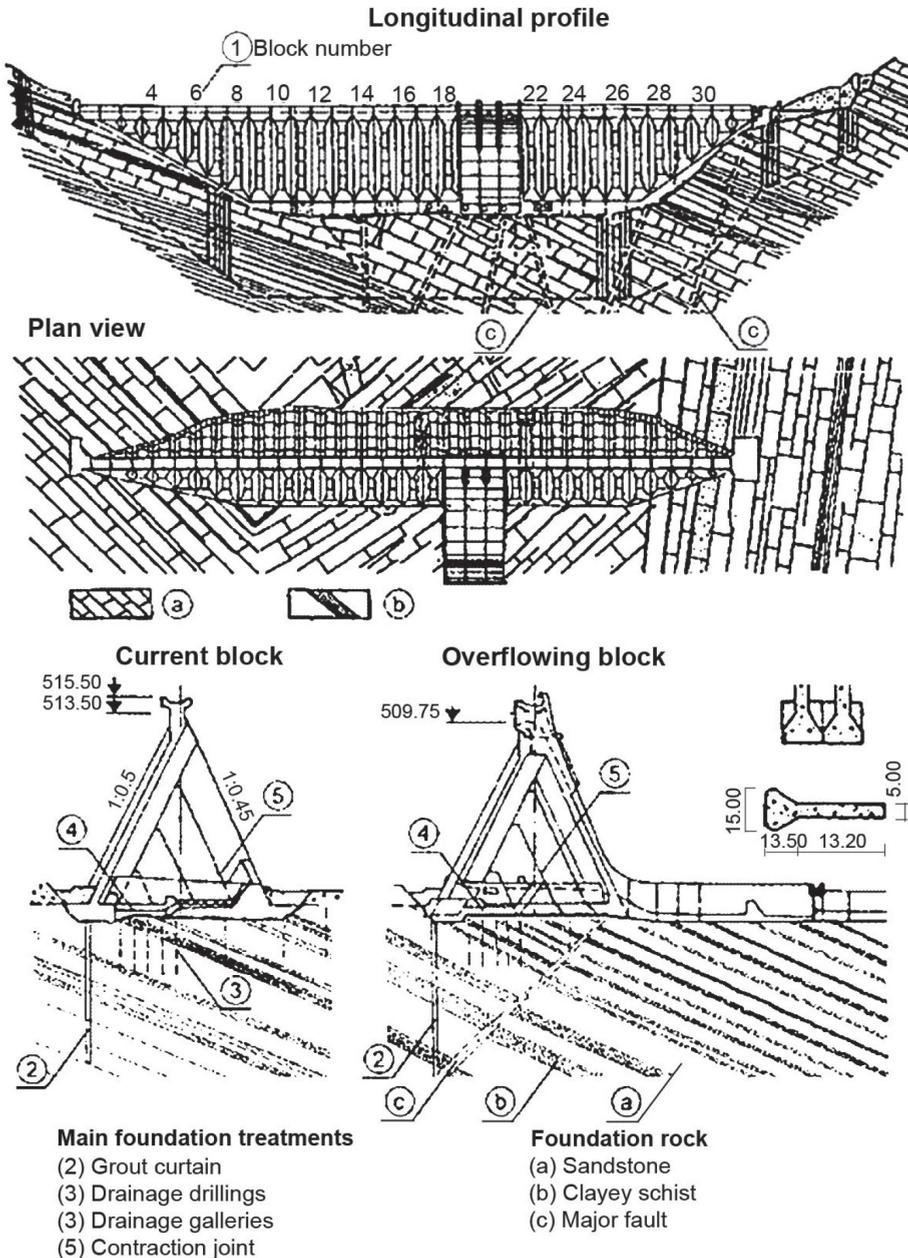
Figure 1. Poiana Uzului dam characteristics.

Poiana Uzului reservoir was performed in order to provide an active storage of $80 \times 10^6 \text{ m}^3$ for water supply in the downstream area. The dam is a concrete buttress one with a height of 80.4 m and a concrete volume of 70,000 m^3 . The dam is divided in 33 blocks out of which the three blocks in the central zone are overflowing. The buttress of each block is supported at the base b/a 15 m foundation pad, equal to the head width (Fig. 1). The pad is also used as a support for supplementary loading with fill material to provide the stability against sliding.

The buttress itself is divided into 13.2 m columns by means of construction joints oriented parallel to the downstream face. Consequently independent inclined columns transmit the load from the head of the buttress to the foundation ground. Visiting drainage galleries are provided along the contraction joints between the buttresses, at the foundation level in the upstream zone.

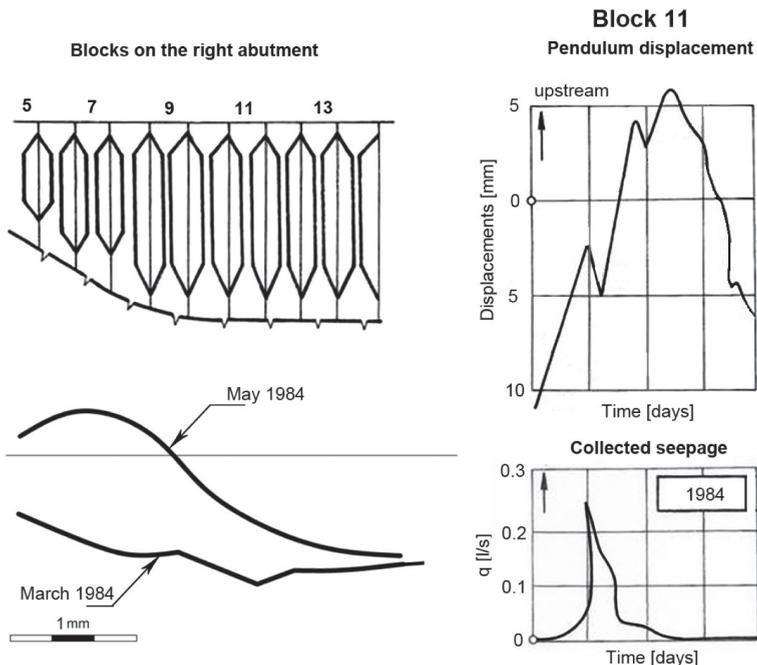
Figure 2. Change of the displacement pattern and increase of drainage flow in April 1984.

The flows drained by drillings present very small values and occur mainly in the right abutment. During the dam monitoring up to 1984, the sudden coming into operation of the drainage drillings was recorded in some years (1979, 1981) but it was considered no special phenomenon. At the end of April 1984, the increase of the flows collected by the drillings was significantly higher, drillings that were inactive came then into operation, water jet occurred directly from the rock in the drainage galleries at joints 516 and 10/11. Simultaneously with these seepage flow increase there were also recorded abnormal displacements of the blocks (Fig. 2). Upward movements and downstream displacements higher than the previous ones were recorded at the blocks located at the base of the right abutment. A sudden change of the displacement pattern (towards downstream) in relation to the general tendency (towards upstream) was also noticed (Constantinescu, Stematiu & Hapau, 2003).

They were rendered evident by the geodesic measurements and by pendulum monitoring data. The analysis of the 1984 phenomenon led to the conclusion that it was similar to the phenomena previously recorded but its amplitude was caused by an unfavorable combination

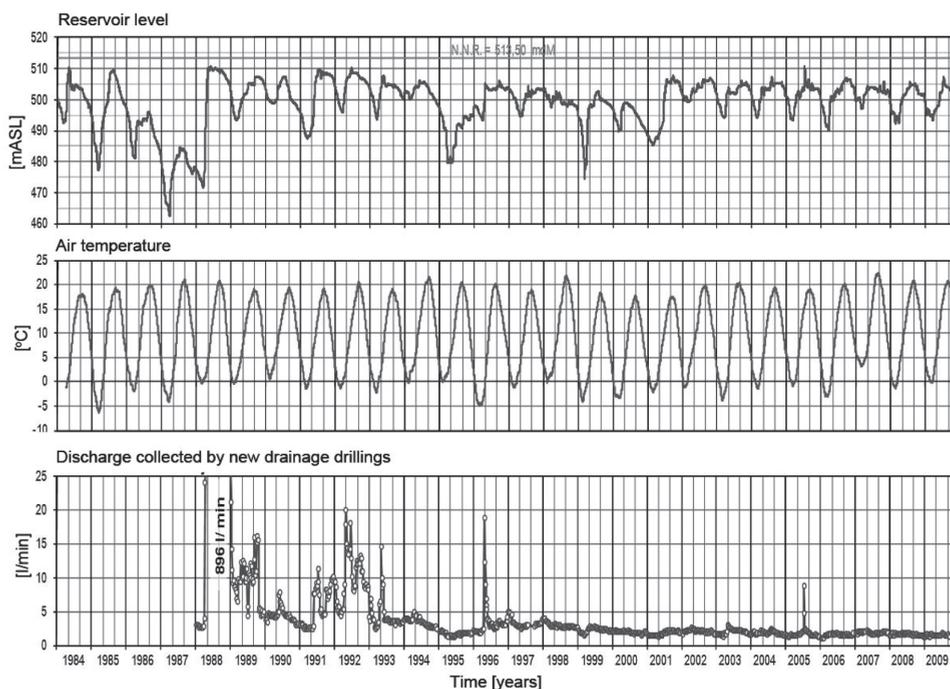
Figure 3. In time reducing the drainage flows.

The analysis of the dam behavior has revealed a stress dependent permeability of the foundation rock. This particular behavior was firstly pointed out by the correlation of the seepage flows with the buttress average temperature and not with the water level in the reservoir as usually happens (Stematiu & Ilie, 1992). The dependence of the drained flows on the reservoir water level is materialized only at reduced temperatures of the buttresses. For the same water level in the reservoir, the flows collected by the drainage system are larger only at reduced temperatures, when the stresses at the upstream toe decrease. From the structural point of view, tensile stresses do occur at the upstream toe of the dam under higher levels in the reservoir associated to lower temperatures in the concrete buttresses. Consequently the rock grouted fissures open. The foundation permeability increases and the drainage system are activated. Where the amount of seepage overcomes the drainage capacity the uplift increases and causes a sudden change of the displacement pattern. When the stress state in the upstream zone of the foundation is mainly compressive the fissure are closed and the seepage toward the drainage system is hindered. In between cycles of drainage reactivation a clogging of the drainage drillings occurs. Even after a large extension of the drainage system performed in 1988 similar phenomena took place (Fig. 3). The new drillings collected very

high seepage flow rates and fine solid particles were carried out by the inflows. The seepage flow in the drainage gallery 8/9 has reached 4.5 ... 5.0 l/s while during the incident it was less than 0.9 l/s. Very soon the flow rates decreased and the collected seepage was clear.

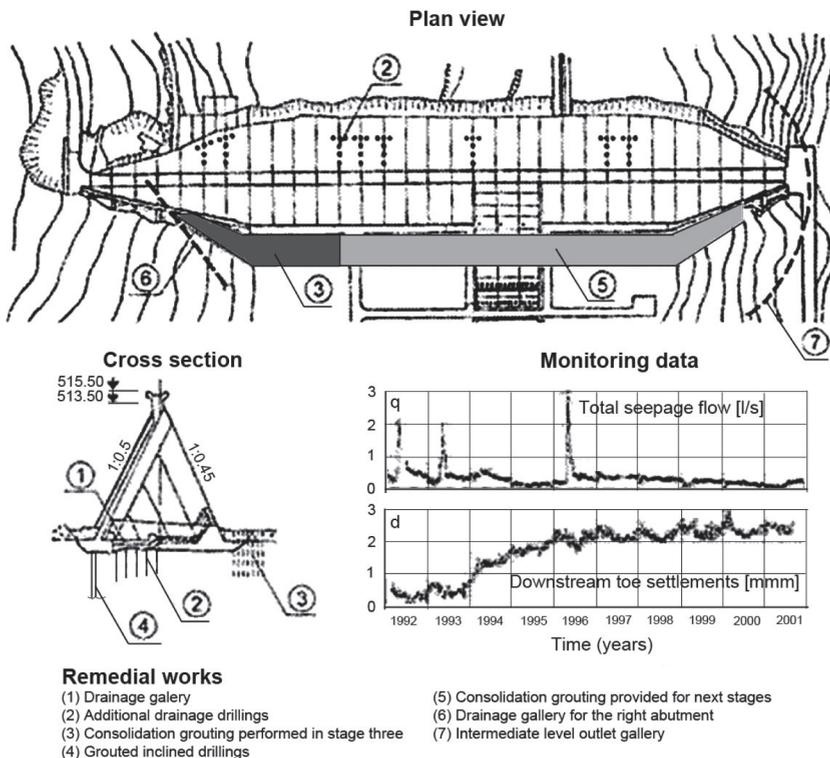
In a second phase a complete program of remedial works was designed (ICOLD, 2000). It comprises (Fig. 4):

- a supplementary drainage system of the dam foundation;
- closure of preferential seepage paths through the grout curtain;

Figure 4. Remedial works program.

- consolidation grouting of the rock mass at the dam downstream toe;
- additional drainage of the left abutment;
- extension of the monitoring system dedicated to measurement of the uplift and rock deformation.

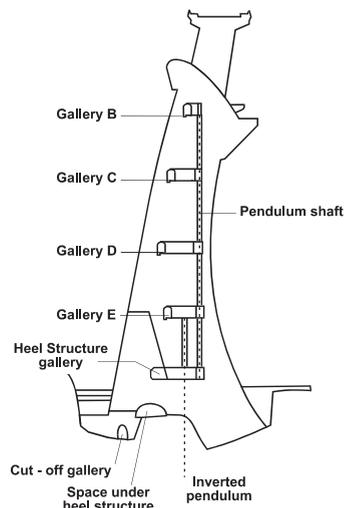
Figure 2. Section through block 1 (centre block).

- Seasonal downstream displacements are clearly evident with the largest displacements as expected in the arch. The maximum displacement of 20 mm was observed on the bridge in the centre of the arch (see Figure 2);

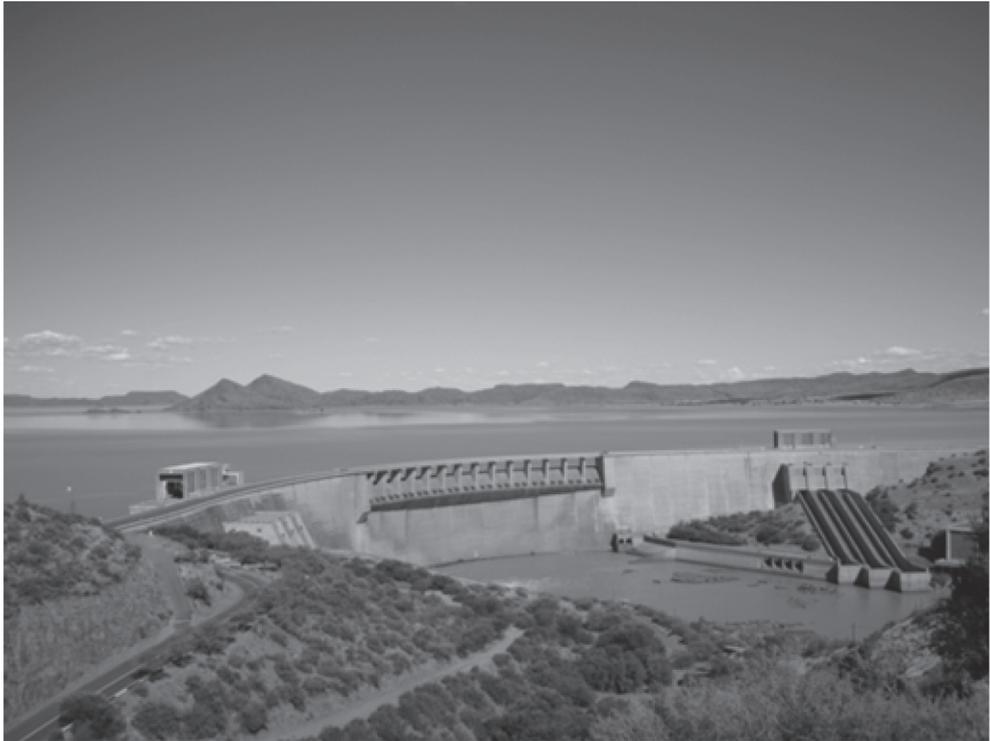
Figure 3. Downstream view of Gariep Dam.

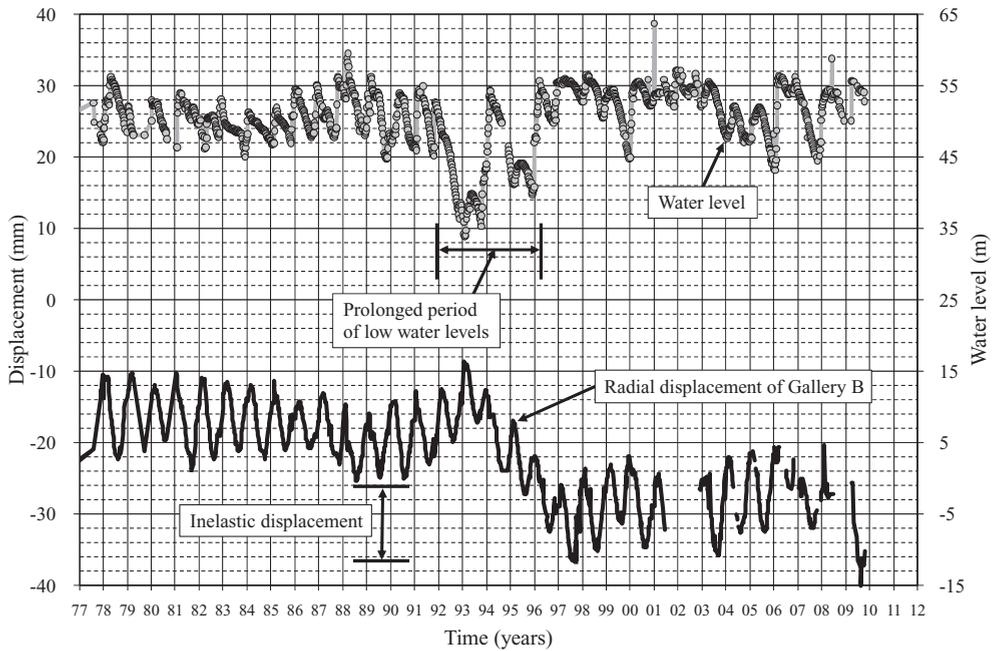
Figure 4. Radial pendulum displacement of Gallery B in the centre of the wall (block 1) (upstream movement is positive).

The performance of the central part of the wall (mainly the double curvature arch) is monitored on a weekly basis by means of 7 pendulum systems (consisting of normal hanging pendulums in the concrete as well as inverted pendulums in the foundations). From these results the following were observed:

- As expected seasonal radial displacement of the structure is evident as well as the influence of water levels on the behaviour of the arch. No seasonal tangential displacement is observed; and

- Under “normal” conditions with the water levels not lower than 13 m below full supply level no abrupt inelastic radial displacement is evident. It is important to note that after the two prolonged periods of low water levels in the early and middle 1990s where the water level dropped to lower levels, it is clearly evident that some inelastic displacement in a downstream direction has occurred. This occurred gradually over a period of time—with a maximum inelastic displacement of 12 mm evident in Gallery B of block 1 i.e. the centre of the wall (see Figure 2 for a section through block 1 and Figure 4 for the radial pendulum displacements of Gallery B (top gallery) in the centre of the wall (block 1)). This observation is confirmed by the results of the geodetic survey system comprising triangulation levelling and traversing through selected galleries (see paragraph 2.2 below). This phenomenon could probably be attributed to the poro-plastic behaviour of the arch structure highlighting the importance of the effect of pore pressures in the concrete. This hypothesis is confirmed in the results of 3D-crack gauges (see paragraph 2.3 below).

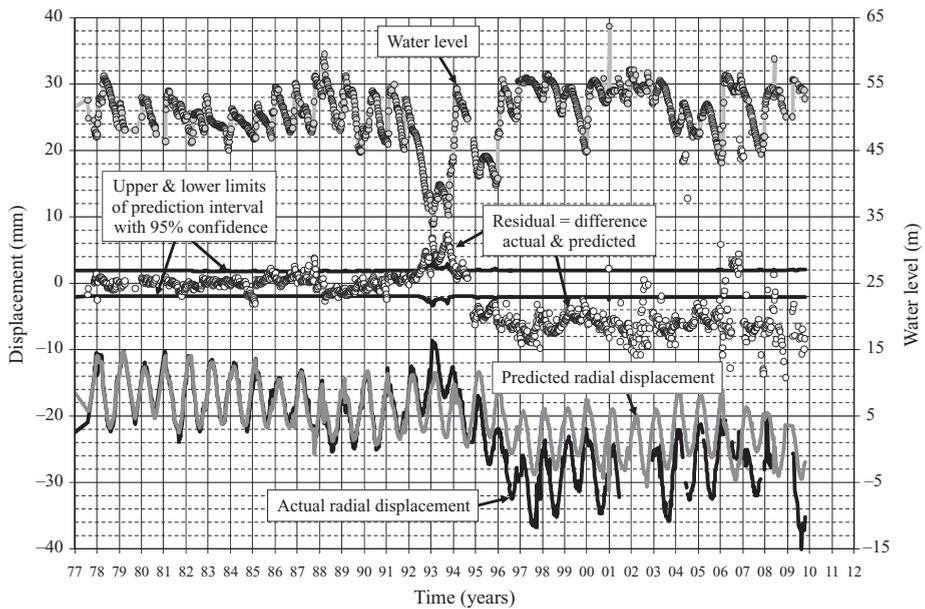
Figure 5. Regression results of pendulum displacement of Gallery B using a regression period from 1977 to 1992 (upstream movement is positive).

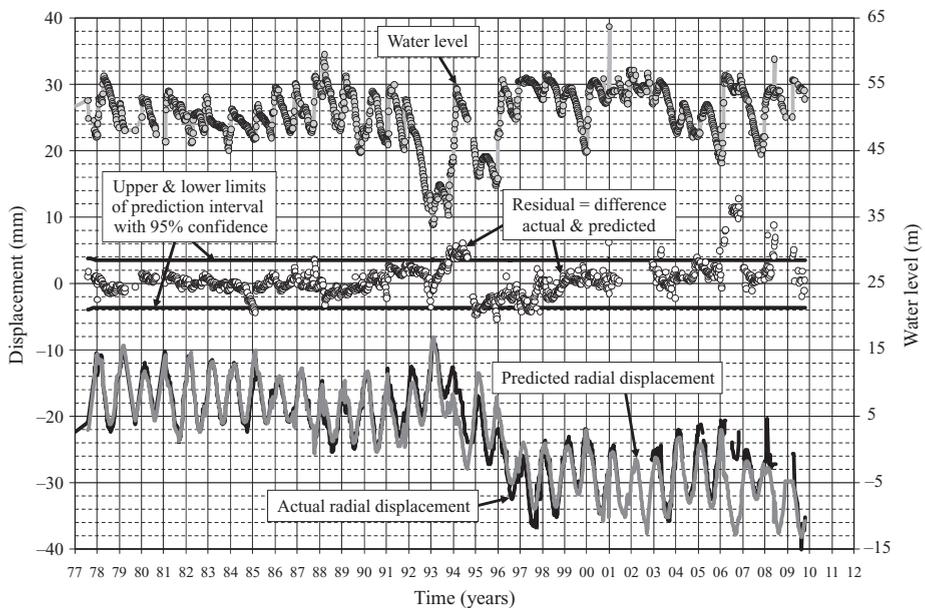
Figure 6. Regression results of pendulum displacement of Gallery B using a regression period from 1977 to 2003 (upstream movement is positive).

the radial pendulum displacements of Gallery B in the centre of the wall as well as the residuals and the 95% prediction interval limits. The improvement is mainly due to the regression model making provision of a total inelastic displacement of 14 mm over a 24 year period with the majority of the inelastic displacement taking place during the prolonged periods of low water levels.

When using a regression period from the end of construction to the beginning of 2003, it is evident that the proposed regression model predicts displacements most of the time within the 95% prediction interval limits for the residuals. See Figure 6 for the regression results of

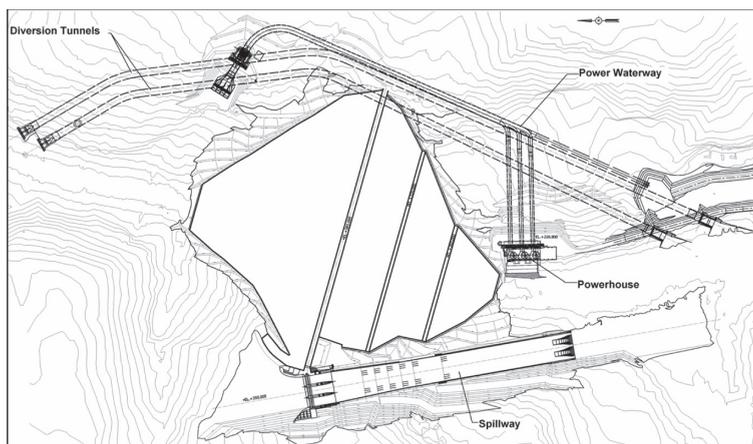
Figure 1. Project layout.

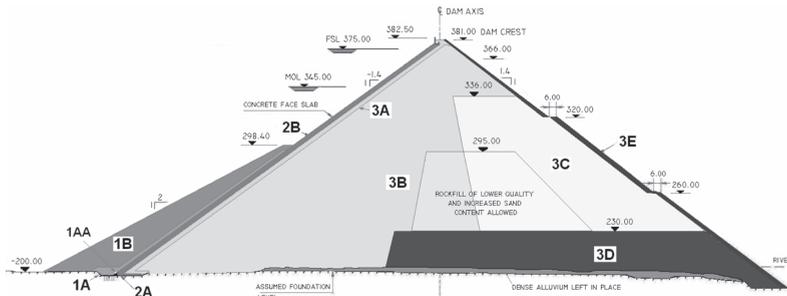
Figure 2. Dam zoning.

For the rockfill fresh to moderately weathered sandstone was used whereby the lower quality material was placed in the central zone of the dam (see Ch. 2.2).

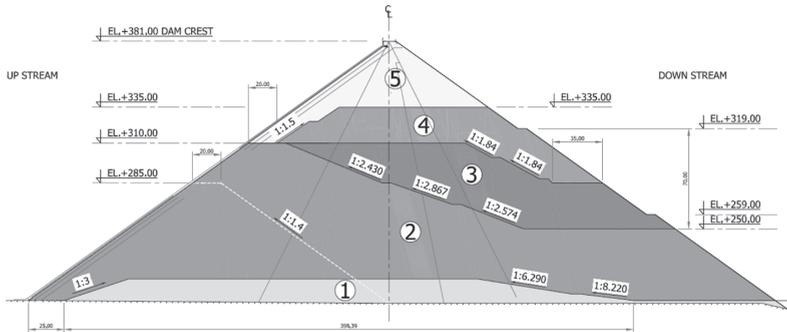
Figure 3. Dam construction stages.

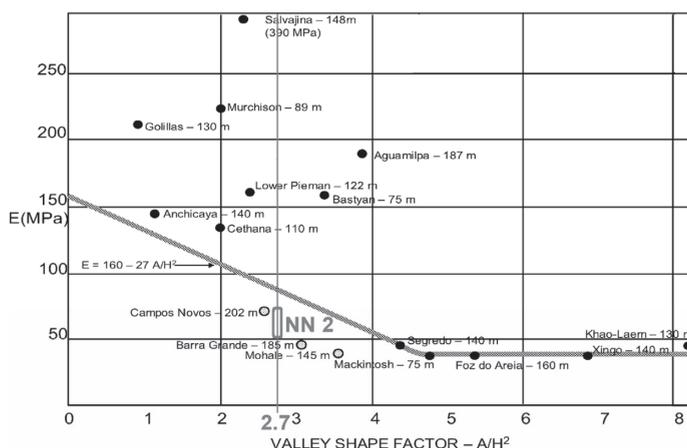
Figure 4. Graph deformation modulus vs. valley shape factor (after Pinto (2007)).

The dam is situated in a steep “V”-shaped valley. The concrete face slab has an area of about 88,000 m² and the valley shape factor is $A/H^2 = 2.7$. Considering this valley shape factor, increased movements of the face slab panels towards the river bed and resulting horizontal stresses in the central face slab panels were expected and considered in the design. Figure 4 shows the valley shape factor of NN2 CFRD plotted on the graph developed by Pinto (2007).

With an assumed deformation modulus of 50 to 70 MPa the conditions at NN2 are about the same as at Campos Novos and Barra Grande CFRD where compression cracking of the face slab did occur.

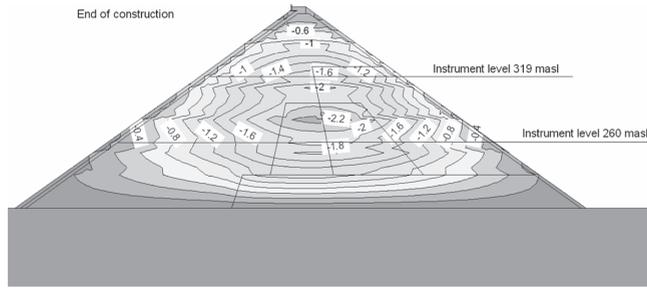
Figure 5. Dam settlements (in m) at the end of construction.

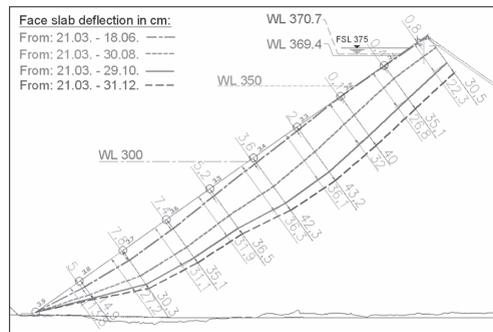
Figure 6. Face slab deflection derived from tiltmeter readings.

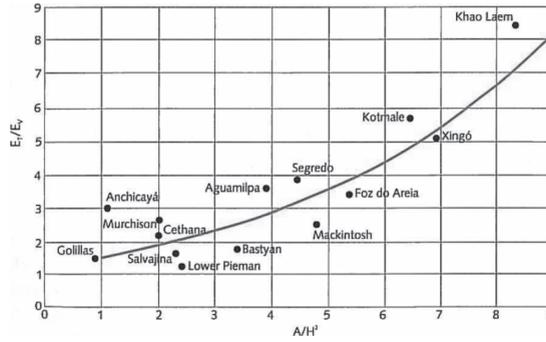
Figure 7. Ratio E_T/E_V as a function of A/H^2 (Pinto & Marques Filho (1998)).

The transverse modulus E_T is higher than the vertical modulus E_V (E_V is equivalent to the modulus during construction E_{rc} as defined in Equation 1) due to a rotation of the principal stresses within the rockfill and rockfill consolidation during construction. Observed values are generally 1.5 to 5 times higher than the vertical modulus depending greatly on the valley shape factor A/H^2 , but certainly also on the creep characteristics of the rockfill. Knowing the vertical modulus E_V calculated from the measured settlements during construction E_T can be estimated using the graph developed by Pinto & Marques Filho (1998) (Fig. 7).
