# DESIGN OF HIGHWAY BRIDGES

AN LRFD APPROACH

FOURTH EDITION

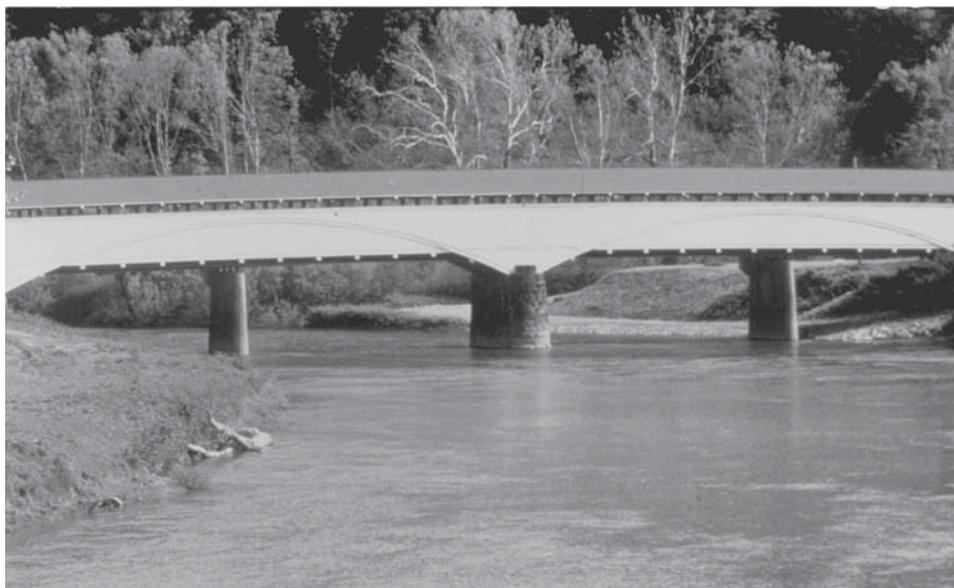
In contrast to the trussed arch of Palmer and Wernwag, Burr utilized an arched truss in which a truss is reinforced by an arch (Fig. 1.3) and patented his design in 1817. An example of one that has survived until today is the Philippi Covered Bridge (Fig. 1.4) across the Tygant's Valley River, West Virginia. Lemuel Chenoweth completed it in 1852 as a two-span Burr arched truss with a total length of 577 ft (176 m) long. In later years, two reinforced concrete piers were added under each span to strengthen the bridge (Exhibit 3 in the color insert). As a result, it is able to carry traffic loads and is the nation's only covered bridge serving a federal highway.

**Fig. 1.4** Philippi covered bridge. (Photo by Larry Belcher, courtesy of West Virginia Department of Transportation.)

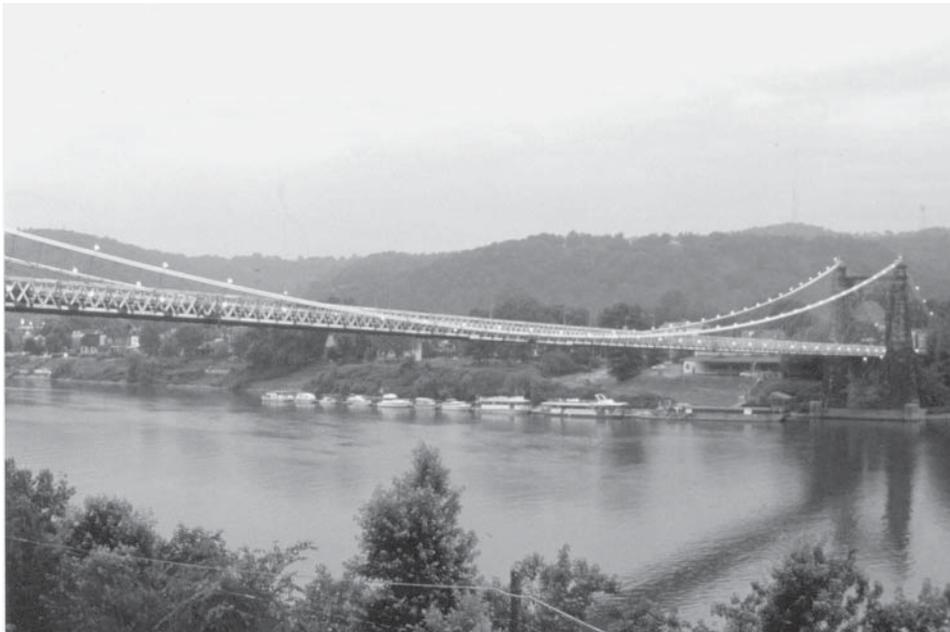
Most engineers are familiar with the suspension bridges of John A. Roebling: the Niagara River Bridge, completed in 1855 with a clear span of 825 ft (250 m); the Cincinnati Suspension Bridge, completed in 1867 with a clear span of 1057 ft (322 m); and the Brooklyn Bridge, completed in 1883 with a clear span of 1595 ft (486 m). Of these three wire cable suspension bridges from the nineteenth century, the last two are still in service and are carrying highway traffic. However, there is one other long-span wire cable suspension bridge from this era that is noteworthy and still carrying traffic: the Wheeling Suspension Bridge completed in 1849 with a clear span of 1010 ft (308 m) (Fig. 1.11).

**Fig. 1.11** Wheeling Suspension Bridge. (Photo by John Brunell, courtesy of West Virginia Department of Transportation.)

The original Wheeling Suspension Bridge did not have the stiffening truss shown in Figure 1.11. This truss was added after a windstorm in 1854 caused the bridge to swing back and forth with increased momentum, the deck to twist and undulate in waves nearly as high as the towers, until it all came crashing down into the river (very similar to the Tacoma Narrows Bridge failure some 80 years later). A Web search for “Tacoma Narrows Movie” will provide several opportunities to view movies that illustrate the failure.

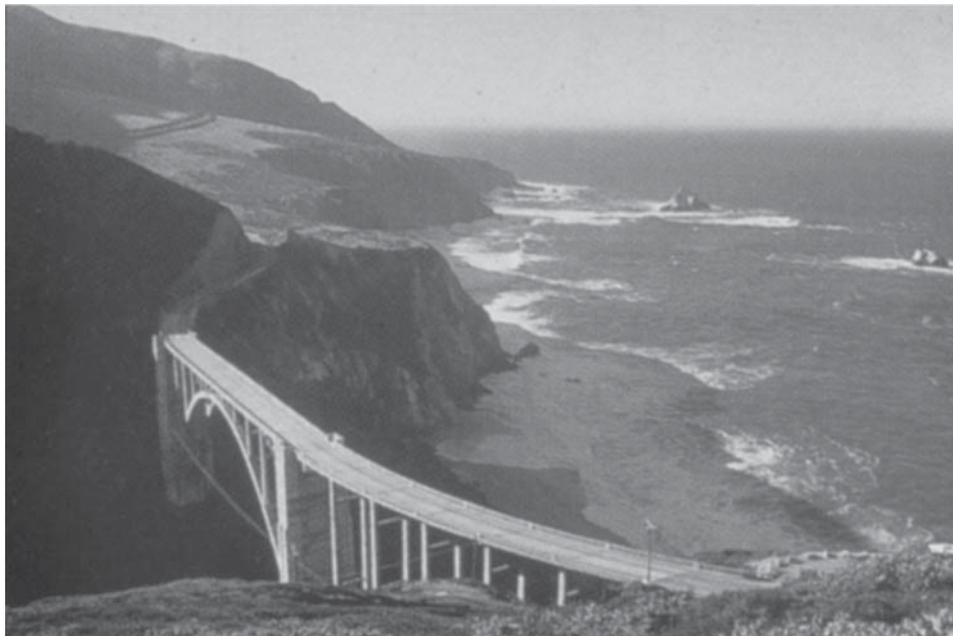
7-span, open-spandrel Rouge River Bridge on the Oregon Coast Highway near Gold Beach, Oregon, designed by Conde B. McCullough and completed in 1932; the 5-span, open-spandrel George Westinghouse Memorial Bridge across Turtle Creek at North Versailles, Pennsylvania, designed by Vernon R. Covell and completed in 1931; and the 360 ft (100 m) single-span, open-spandrel Bixby Creek Bridge south of Carmel, California, on State Route 1 amid the rugged terrain of the Big Sur (Fig. 1.14), designed by F. W. Panhorst and C. H. Purcell and completed in 1933 (Jackson, 1988).

**Fig. 1.14** Bixby Creek Bridge, south of Carmel, California. [From Roberts (1990). Used with permission of American Concrete Institute.]

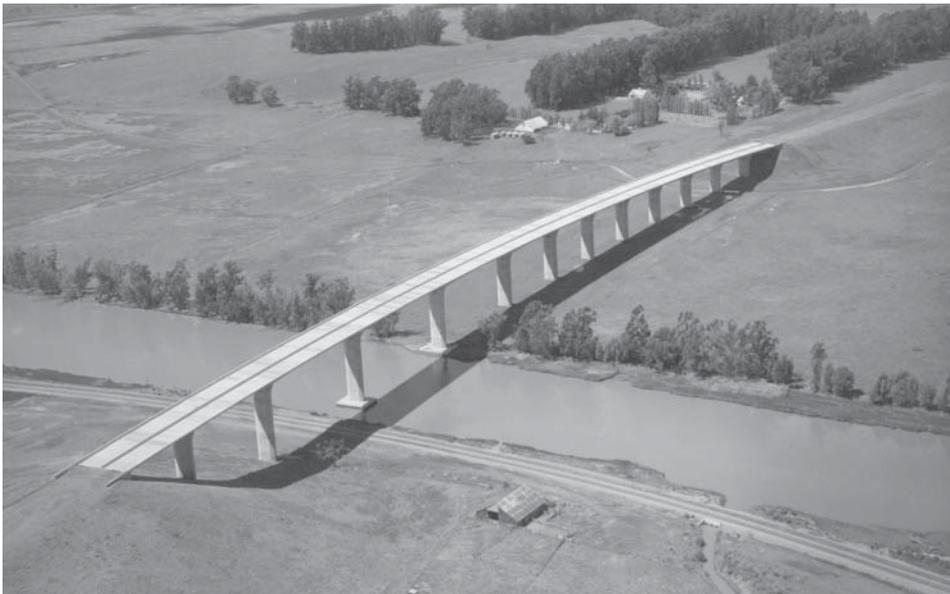
the concrete girder bridge is not only functional but can also be designed to be aesthetically pleasing (Fig. 1.15).

**Fig. 1.15** Napa River Bridge. (Photo courtesy of California Department of Transportation.)

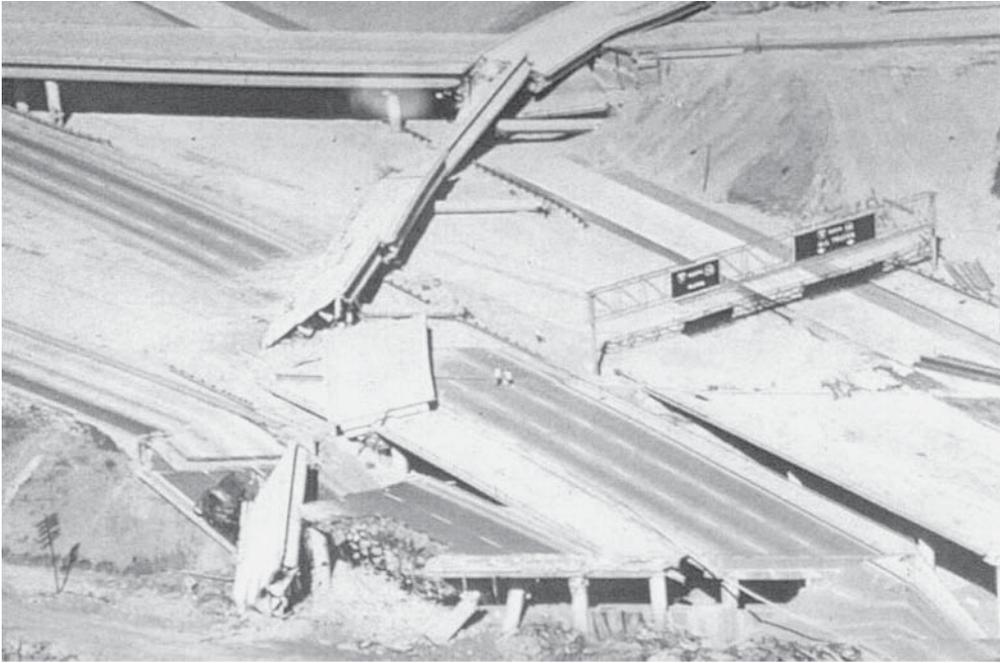
**Fig. 2.4** View looking north at the I-5 and I-210 interchange after the quake showing the collapsed South Connector Overcrossing structure (bridge 2) in the center, the North Connector Overcrossing structure (bridge 3) at the top, and bridge group 4 at the bottom. (Photo courtesy E. V. Leyendecker, U.S. Geological Survey.)

When the earthquake struck, the South Connector structure (Fig. 2.4, center) collapsed on to the North Connector and I-5, killing the two men in the pickup truck. The North Connector superstructure (Fig. 2.4, top) held together, but the columns were bent double and burst their spiral reinforcement (Fig. 2.5). One of the group of parallel bridges on I-5 was also struck by the falling South Connector structure, and two others fell off their bearings (Fig. 2.4, bottom). The bridge immediately to the east suffered major column damage and was removed.

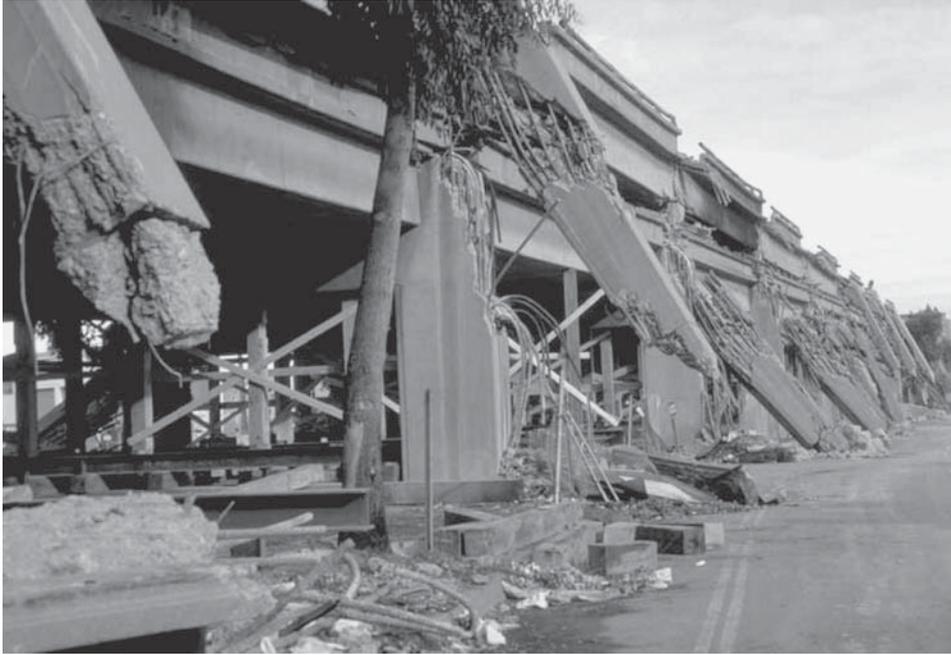
**Fig. 2.11** Cypress Viaduct. (Photo courtesy H. G. Wilshire, U.S. Geological Survey.)

**Description** The 1989 Loma Prieta earthquake that occurred on October 17 resulted in over \$8 billion in damage and loss of 62 lives. Figure 2.11 illustrates the Cypress

Viaduct in Oakland. This bridge was perhaps one of the most reported-on structures by the national media as this double-deck bridge failed in shear within the columns and pancaked the bridge on traffic below.

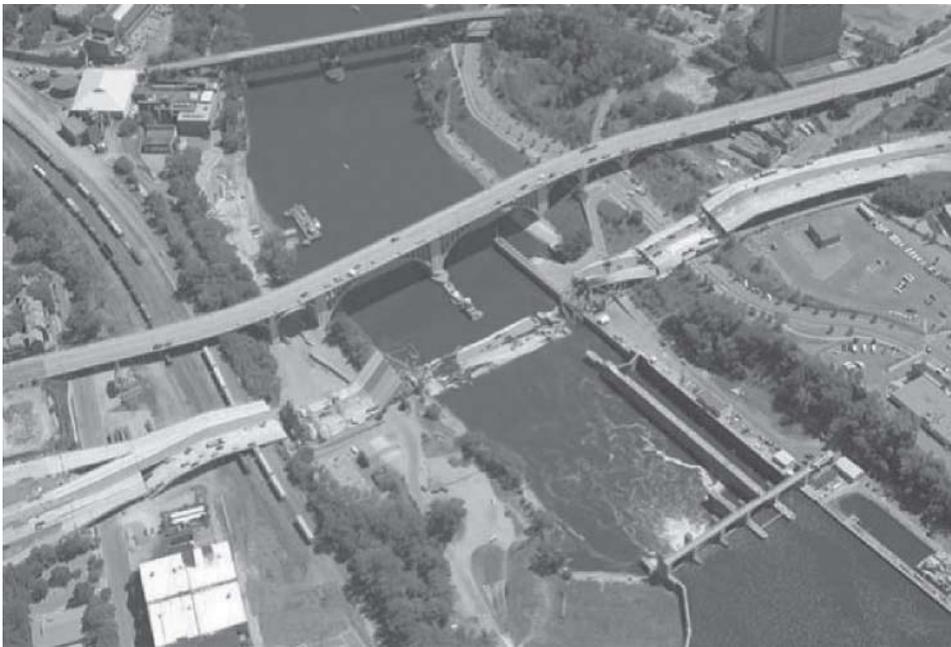
**Fig. 2.12** Aerial view of I-35W Bridge after collapse. (NTSB, 2008).

Highway Bridge over the Mississippi River in Minneapolis, Minnesota, experienced a catastrophic failure in the main truss span of the deck truss. As a result, 1000 ft (305 m) of the deck truss collapsed, with about 456 ft (140 m) of the main span falling 108 ft (33 m) into the 15 ft (4.6 m) deep river (Fig. 2.12). A total of 111 vehicles were on the portion of the bridge that collapsed. As a result of the bridge collapse, 13 people died, and 145 were injured (NTSB, 2008).

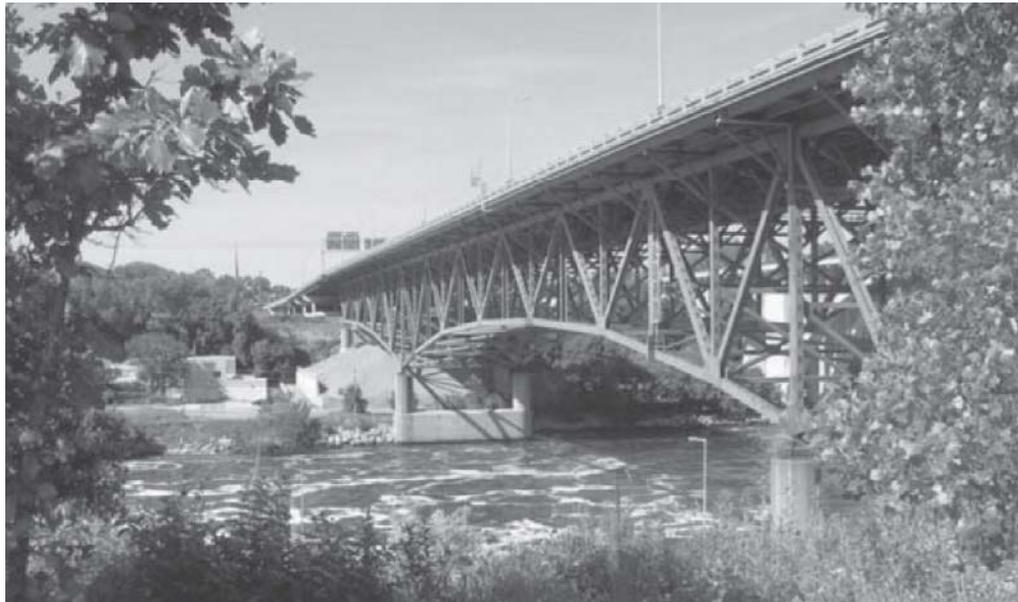
**Fig. 2.14** Center span of I-35W bridge looking northeast. The center span is supported by pier 6 on the near (south) riverbank and pier 7 on the far (north) riverbank. (NTSB, 2008).

**Description** The bridge elevation is shown in Figures 2.13 and 2.14. A total of 11 of the 14 spans were approach spans to the deck truss portion that failed. The original bridge design accounted for thermal expansion using a combination of fixed and expansion bearings for the bridge–pier interfaces. For the deck truss portion, a fixed bearing assembly was located at pier 7. Expansion roller bearings were used at piers 5, 6, and 8.

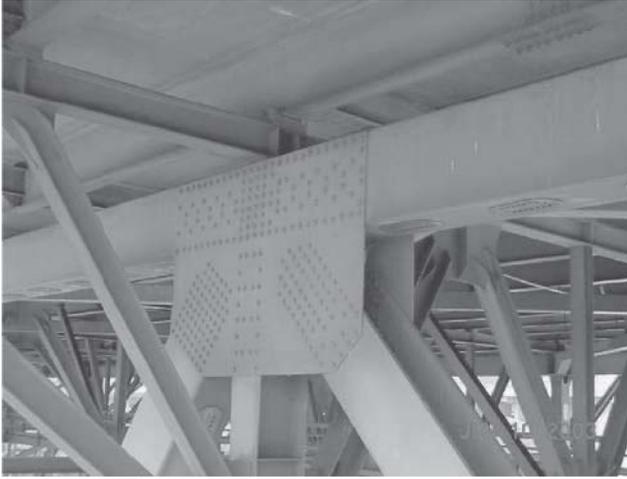
**Fig. 2.15** Typical five-member node (two upper chord members, one vertical member, and two diagonal members) on I-35W Bridge. (NTSB, 2008).

Riveted steel gusset plates at each of the 112 nodes (connecting points) of the two main trusses tied the ends of the truss members to one another and to the rest of the structure. The gusset plates were riveted to the side plates of the box members and to the flanges of the H members. A typical I-35W main truss node with gusset plates is shown in Figure 2.15.

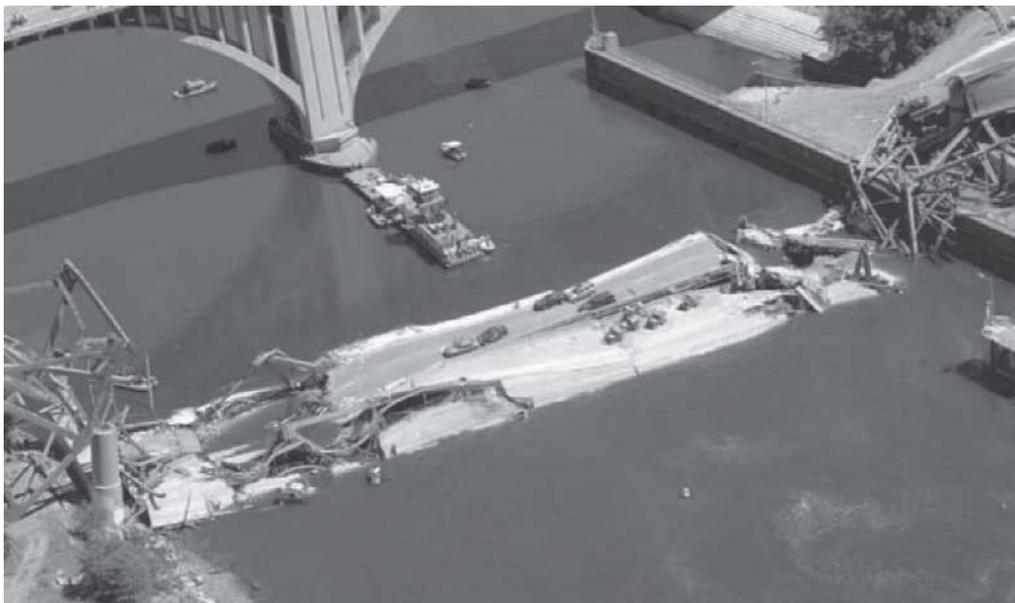
**Fig. 2.16** Collapsed bridge center section, looking southeast. (NTSB, 2008).

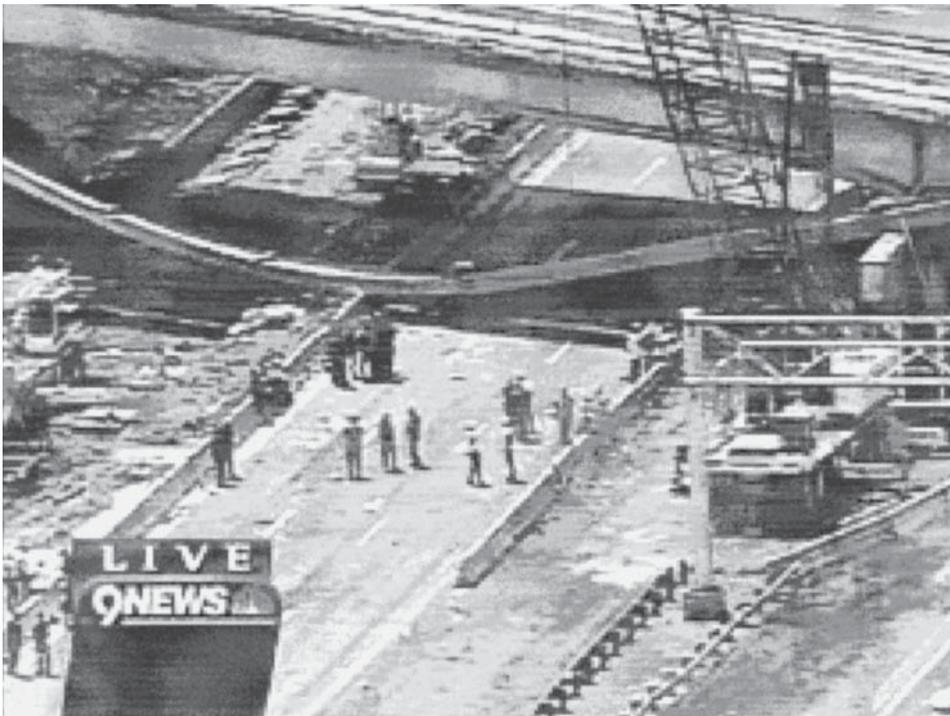
**Fig. 2.18** Bridge failure near Golden, Colorado. (Photo from Golden Fire Department Annual Report 2004, Golden, Colorado. <http://ci.golden.co.us/files/2004fdreport.pdf>.)

provide lateral stability. The girder became unstable, fell, and killed three people. An aerial view is illustrated in Figure 2.18. The Web reference provided and the associated video linked on this page illustrate many aspects of this failure from a first-day perspective. Stability is the likely cause of failure and is commonly the cause—either stability of the girders supporting the deck with wet concrete or the stability of temporary formwork and shoring required to support the structure. In later chapters, construction staging is discussed related to the design. Again, see 9News.com to review what can happen when mistakes occur. This particular incident could have killed many more—the failure occurred on a Sunday morning when traffic volume was relatively light.
